**Revised Nov 2022, Planning Report – Allure Visitor Accommodation at:**

- “Riverside” 297 Primrose Sands Road, Primrose Sands, PID: 9584675 (CT: 181036/19, CT: 181036/20, and CT: 210947/1)

**For: Young-Mundy Property Trust**

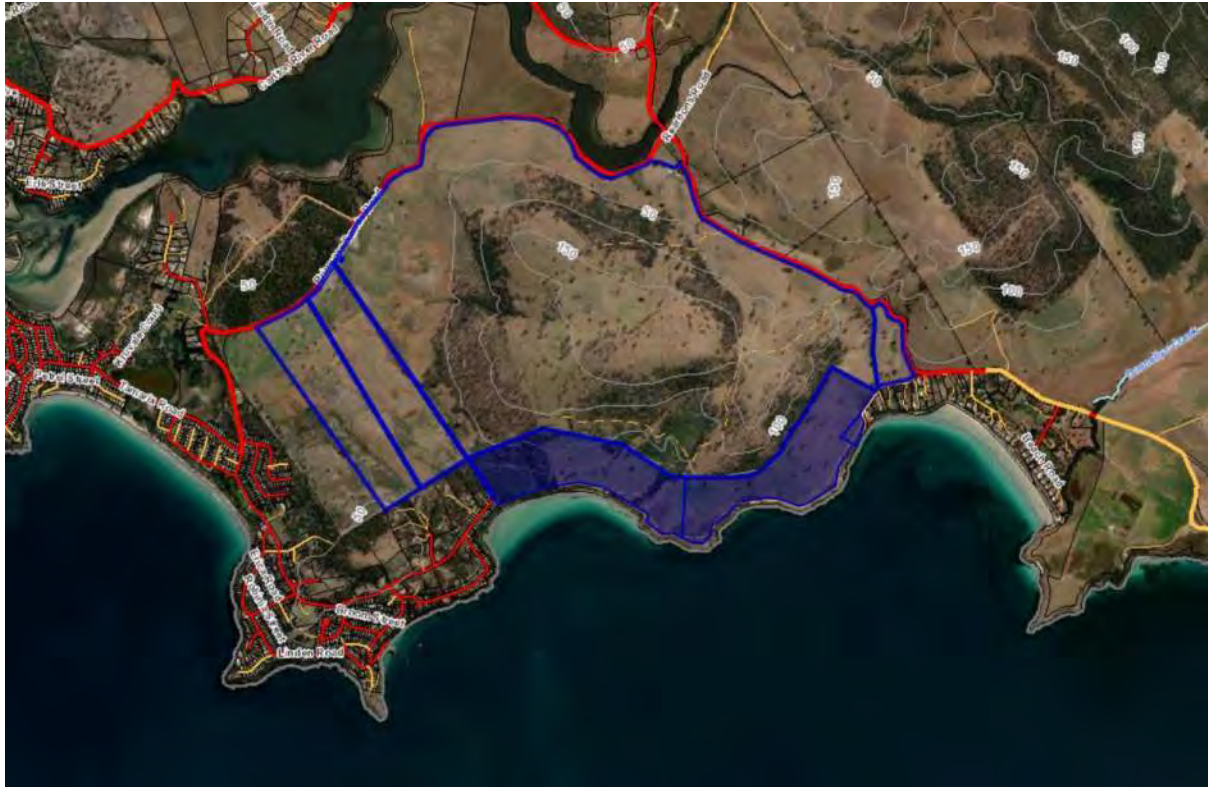
**Figure 1.1a – “Riverside” 297 Primrose Sands Road, Primrose Sands (PID: 9584675) in blue outline. The specific area of the development is restricted to the section shaded blue. (Source LIST Map)**

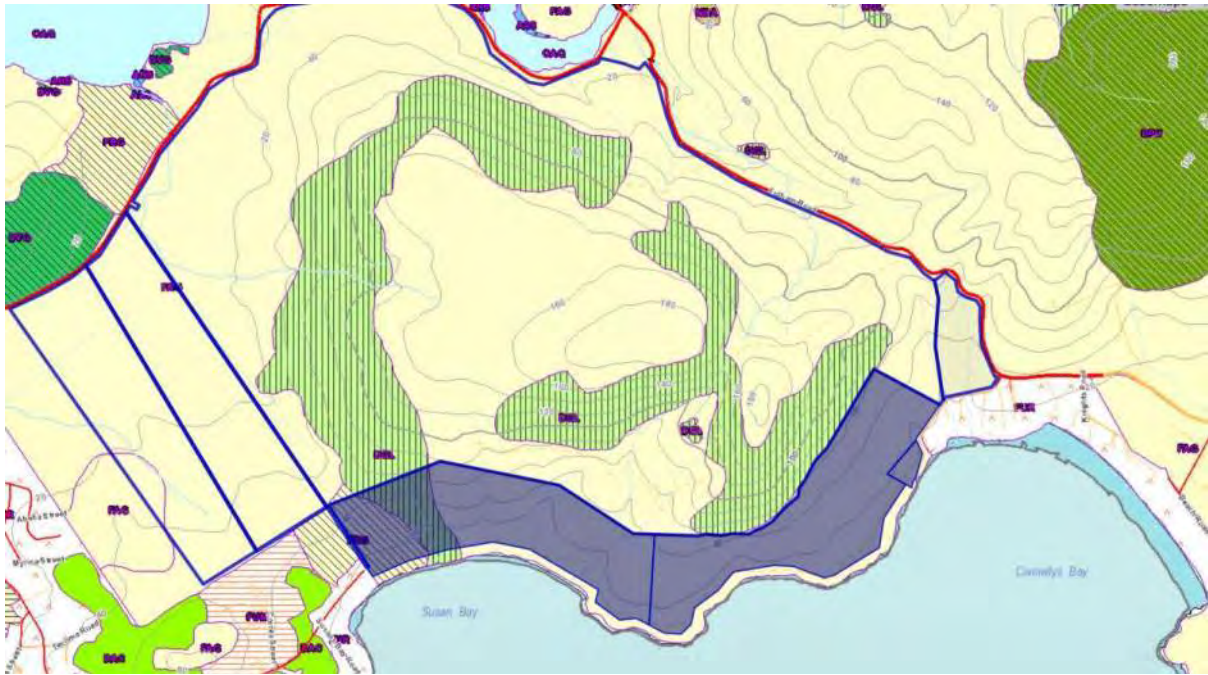
Figure 1.1b – The property in relation the TasVege layer – the yellow area is Agriculture Land (FAG), a strip of *Eucalyptus globulus* dry forest and woodland (DGL), will act as a buffer between the development and Primrose Sands. (Source LIST Map)

Land contained within Lot CT: 210947/1 is mapped with the Biodiversity Overlay, however the TasVeg layers (LIST Map) cite this area as being the vegetation type Agricultural Land (FAG). A site inspection has confirmed this is the case. While older aerial images show some tree cover, much of this was destroyed during the 2013 bushfires, and the understorey has always been grazing pasture. This is backed up by the map Figure 1.1b and the image at Figure 1.1b(i) below.

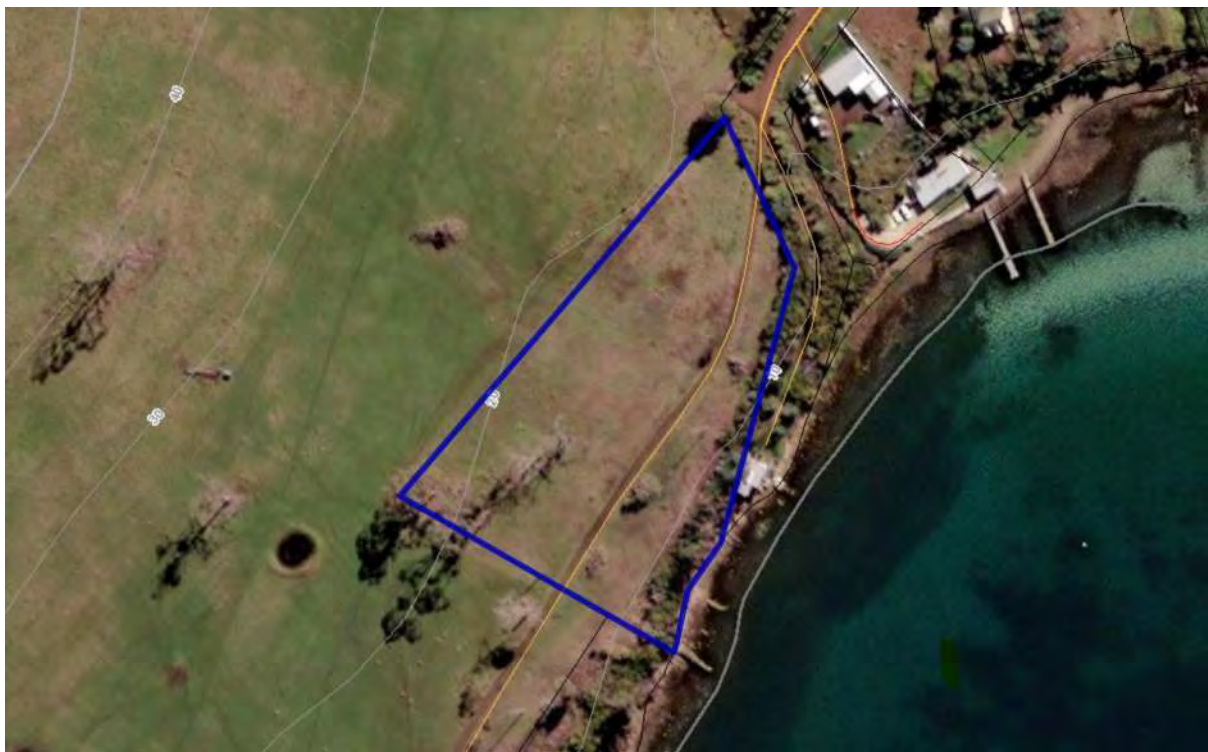
Figure 1.1b(i) - Lot CT: 210947/1 in blue outline. The image shows that the entire site is consistent with the grazing pasture on the adjoining lots and contains only native vegetation around the coastal strip. (Source LIST Map)

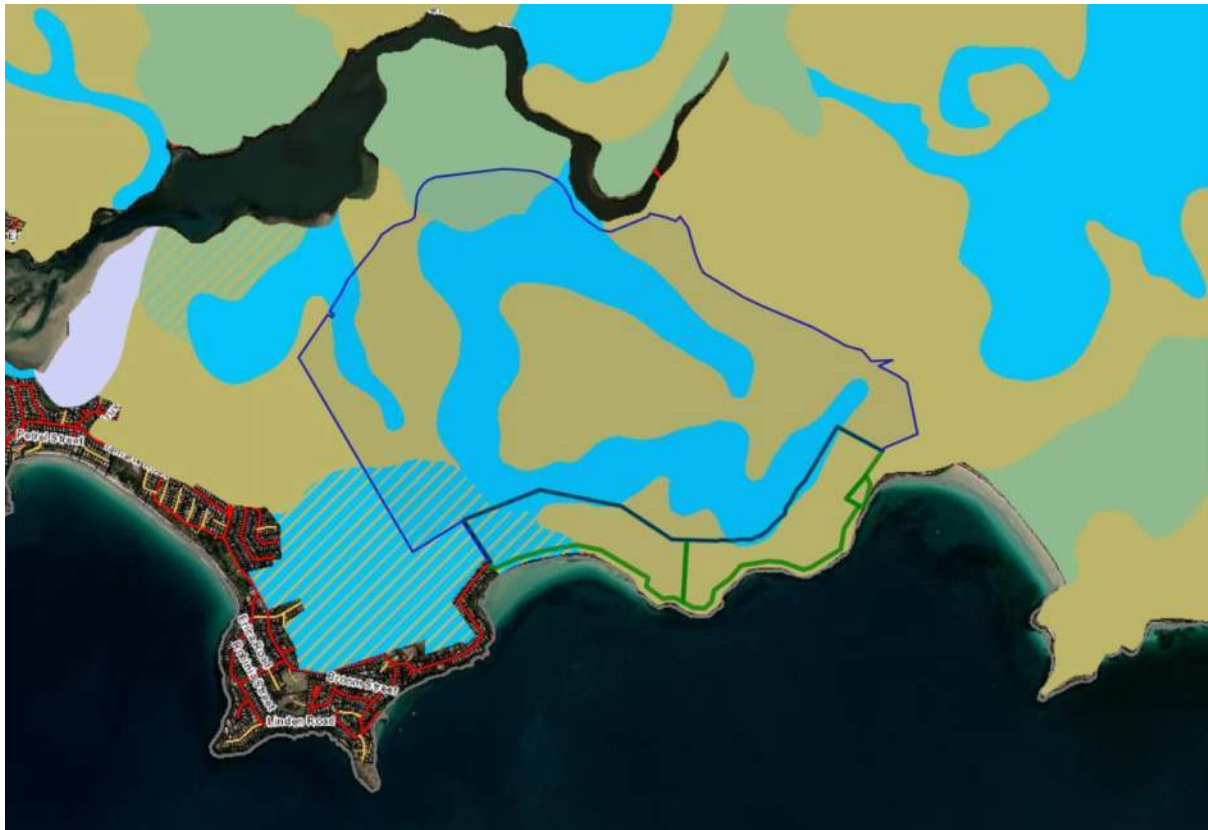
**Figure 1.1c – The property is predominately mapped as Class 5 (olive green shading) or 6 (blue shading), with Class 4 (green shading) at the opposite end of the property from the development site. (Source LIST Map)**

The *Land Capability Survey of Tasmania* mapping cites this land as predominately Class 5 and 6, which is marginal cropping ground and only suitable for grazing. A small area towards Carlton River in the north of the property is classified as Class 4 (Figure 1.1c).

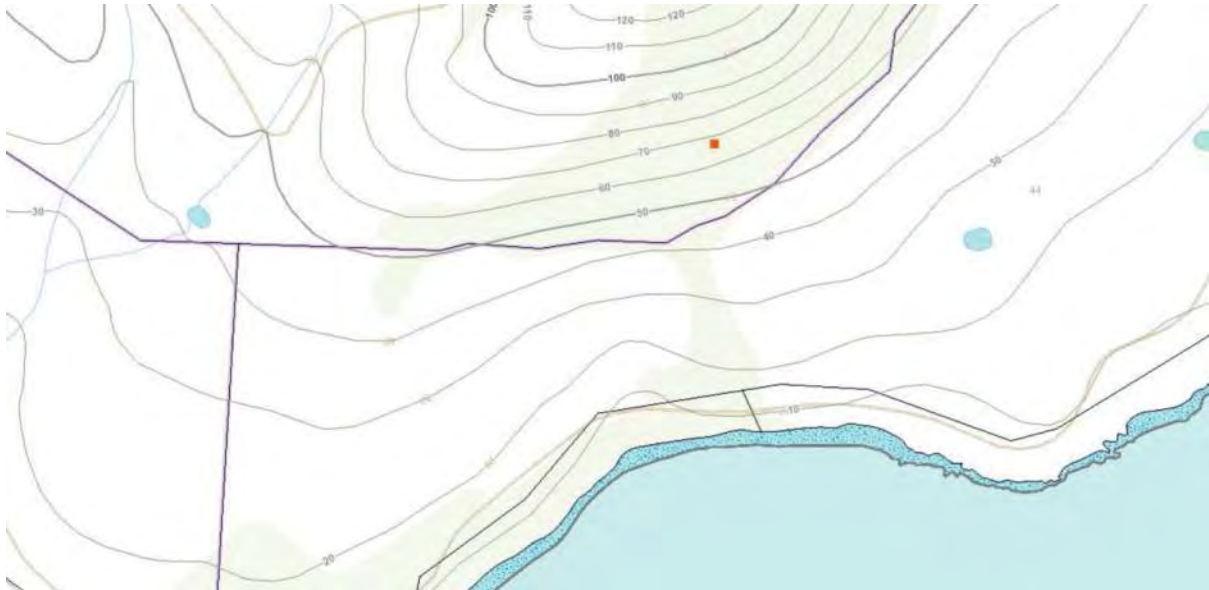
**Figure 1.1d – The orange square indicates the recorded eagle’s nest site, however, on a closer inspection it is unlikely to be a nest of an eagle, nor does the nest appear to be in use. (Source LIST Map)**

The other listed nest can be seen from the southern paddocks (Figure 1.1d); however, it does not appear to be in use. At only 30-40cm in diameter, it appears to be of insufficient size to be an eagles' nest and may belong to a smaller bird of prey or alternatively a magpie or raven. It is noted that at the time of inspection, there was no evidence of occupation such as waste or dropped bone scatter at or near the base of the tree or in its general surrounds, even though visitation occurred during the breeding season for these birds.

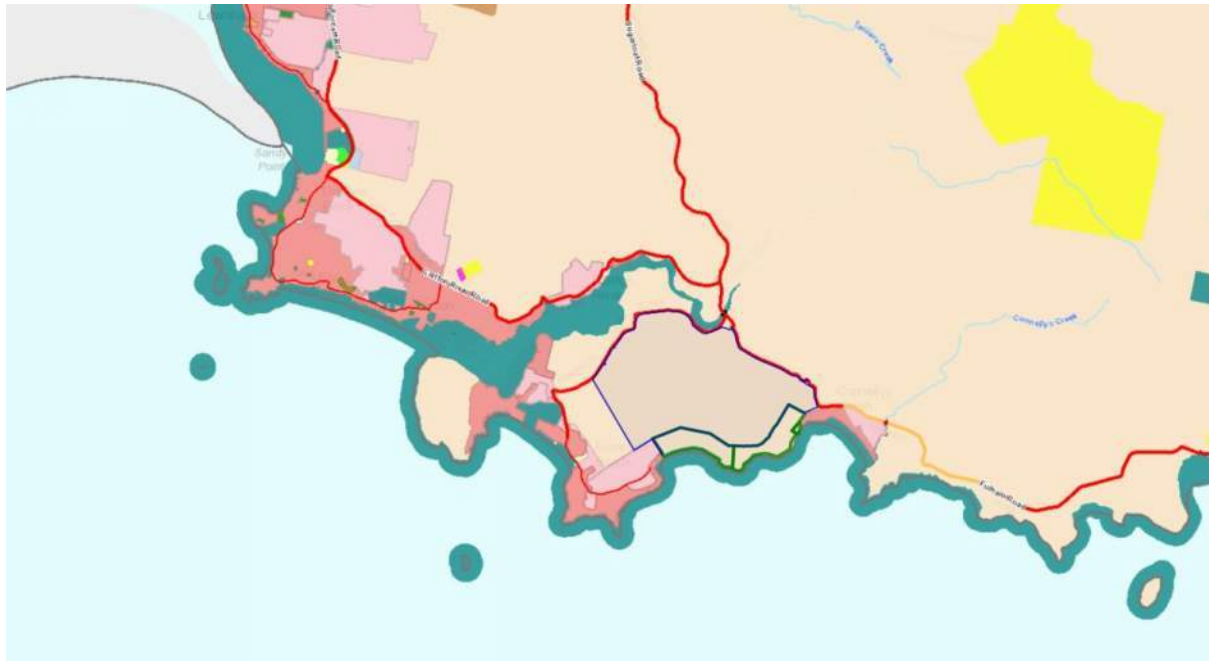
**Figure 1.3a – The image shows the subject property outlined in the centre immediately surrounded by Rural Resource zoned properties to the north and east, but also residential type zoned properties to the east and west of the actual development site. The foreshore to the south is zoned Environmental Management. Over 5km to the east, the yellow area is Utilities zone for the Copping Tip. (Source the LISTmap)**

As shown in Figure 1.3a below, two residential areas are located at either end of the development site, both zoned Low-density Residential and Rural Living. These are the settlements of Connelly’s Marsh to the east and Primrose Sands to the west.

As shown in Figure 1.3a and Figure 1.3b, the Rural Resource Zone has been used as a blanket zone for any land outside of the township or settlement areas. The use of the Rural Resource zoning reflects the significance agricultural and primary industry activity plays within the region. Such importance is emphasised within the zone purpose statements (Part D.26- Clause 26.1).

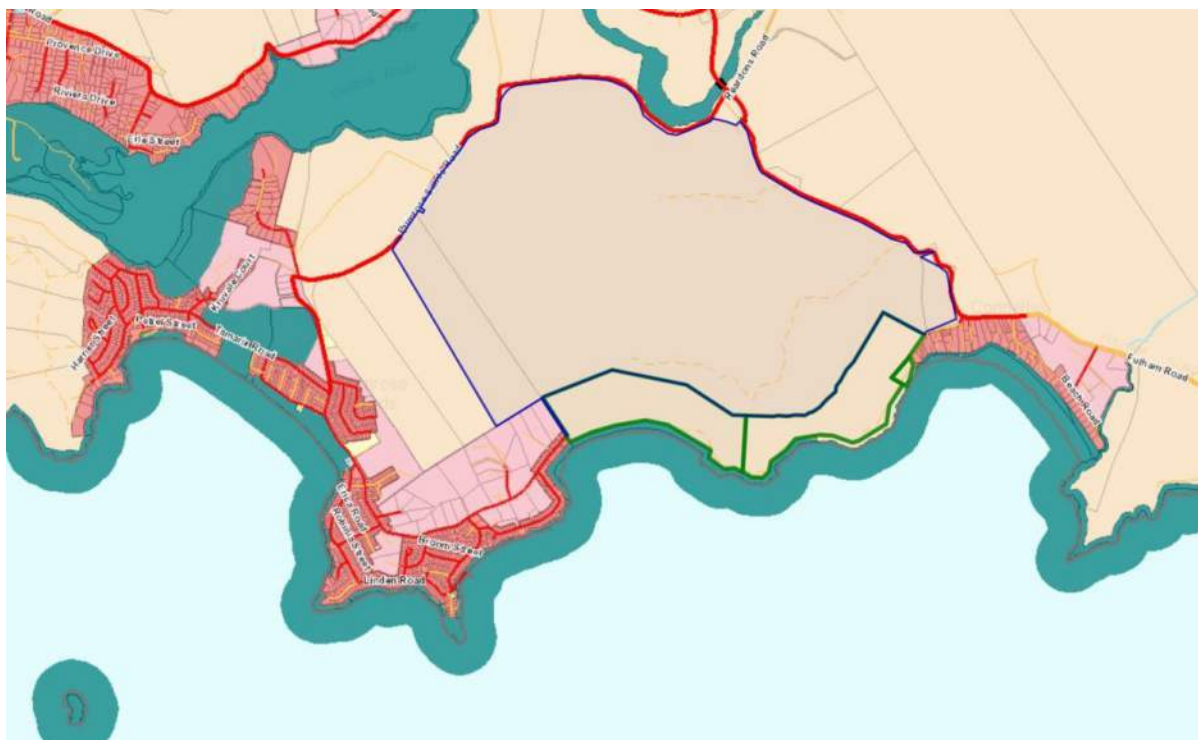
**Figure 1.3b – Closer image showing the subject property in relation to the surrounding lots zoned Rural Resource. (Source the LISTmap)**

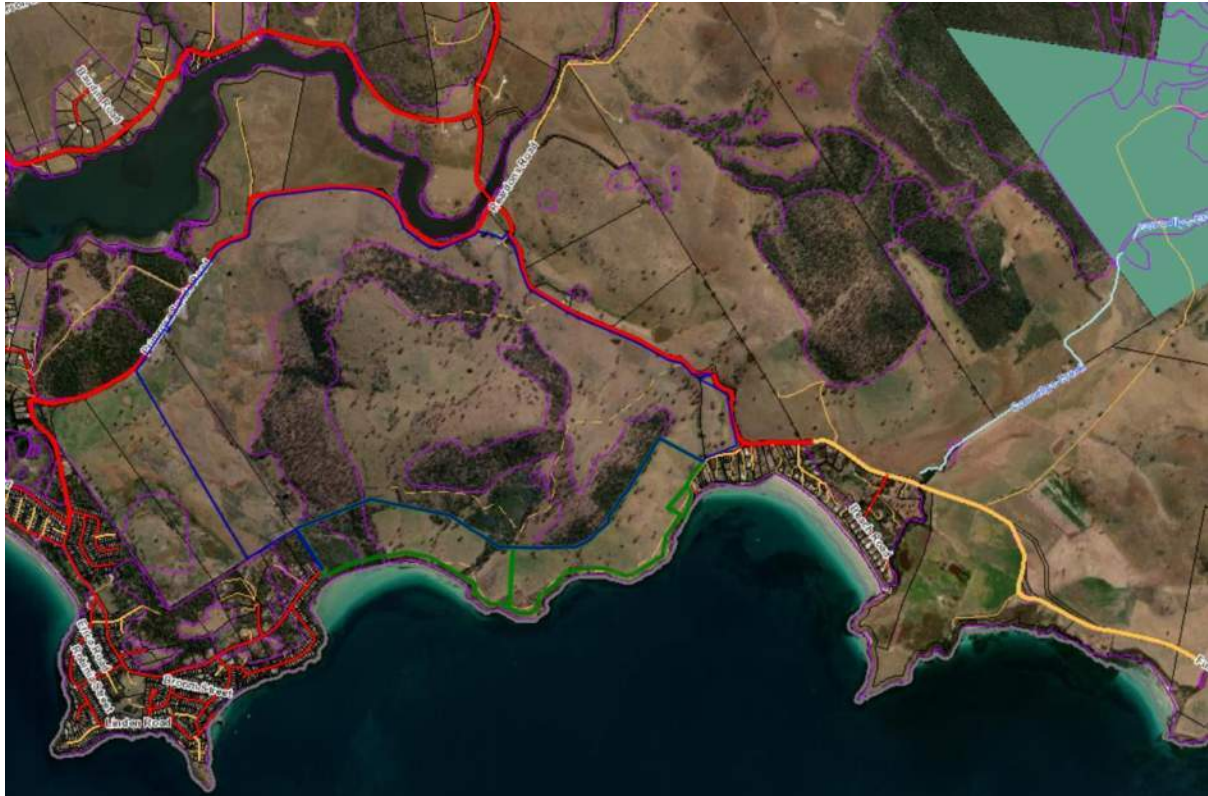
**Figure 1.3c – The green area (top right corner of image) is Private Timber Reserves under the *Forest Practices Act 1985* and is just under 2.8km from the development site at the closest point. The TasVege Live layer has the surrounding vegetation is dominated by Agricultural land (FAG). (Source the LISTmap)**

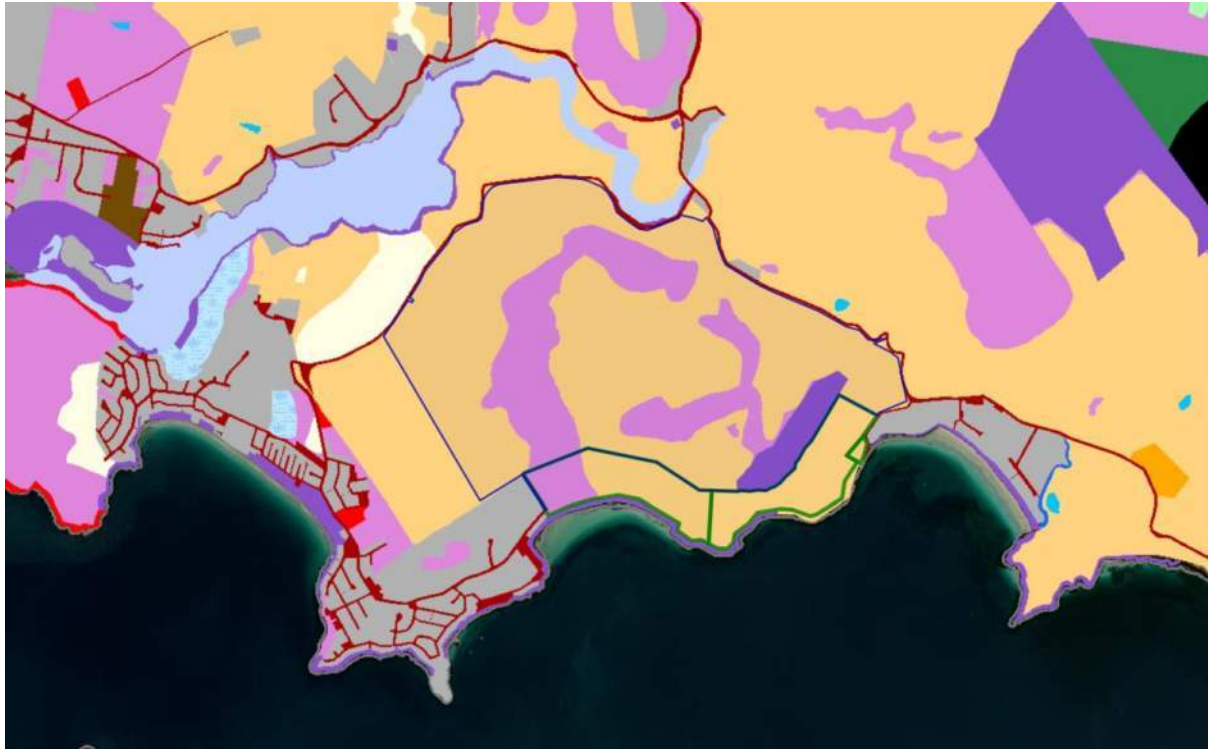
**Figure 1.3d – The above image is an extract from the Tasmanian Land Use 2019 mapping within the LIST Map published 22 December 2020. The property is outlined in dark blue in the centre with the development site outlined in green fronting the coastal area. The colour grey Land Use Code is 5.4.3 *Rural residential without agriculture*, pink Land Use Code is 1.3.3 *Residual native cover*, the yellow colour is Land Use Code is 3.2.0 *Grazing modified pastures*. The dark purple areas are 1.1.5 *Habitat/species management area* (Source the LIST Map)**

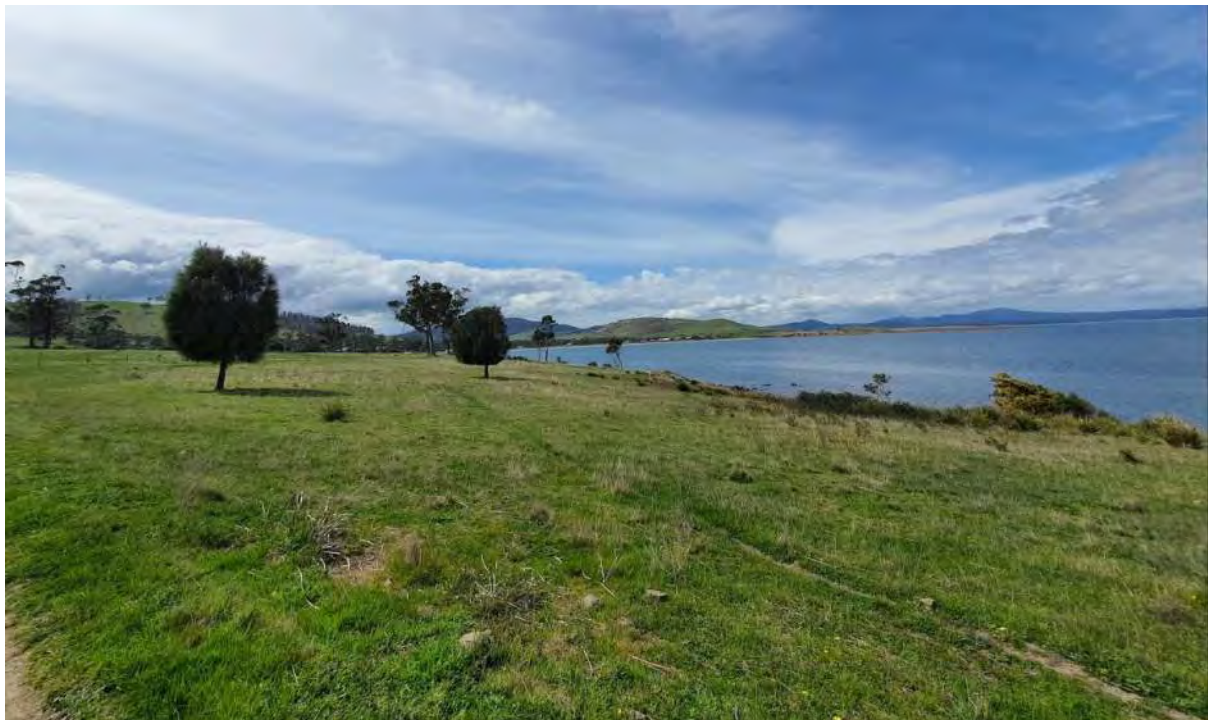
**Figure 3.4b(i) – The eastern end of the development is pasture with minimal native vegetation. The cabins here are to be 50m from the water’s edge.**

Photomontages have been prepared to demonstrate that the colours and proposed finishes of the cabins echo the tones of the rural landscape. By locating the development along the southern boundary, the development allows for the re-growth of native vegetation in the development area due to reduced livestock grazing. The revised site Master Plan and location of the cabins, Lodge and Wellness Centre means that no native vegetation will be removed because of the development (Figure 3.4b).

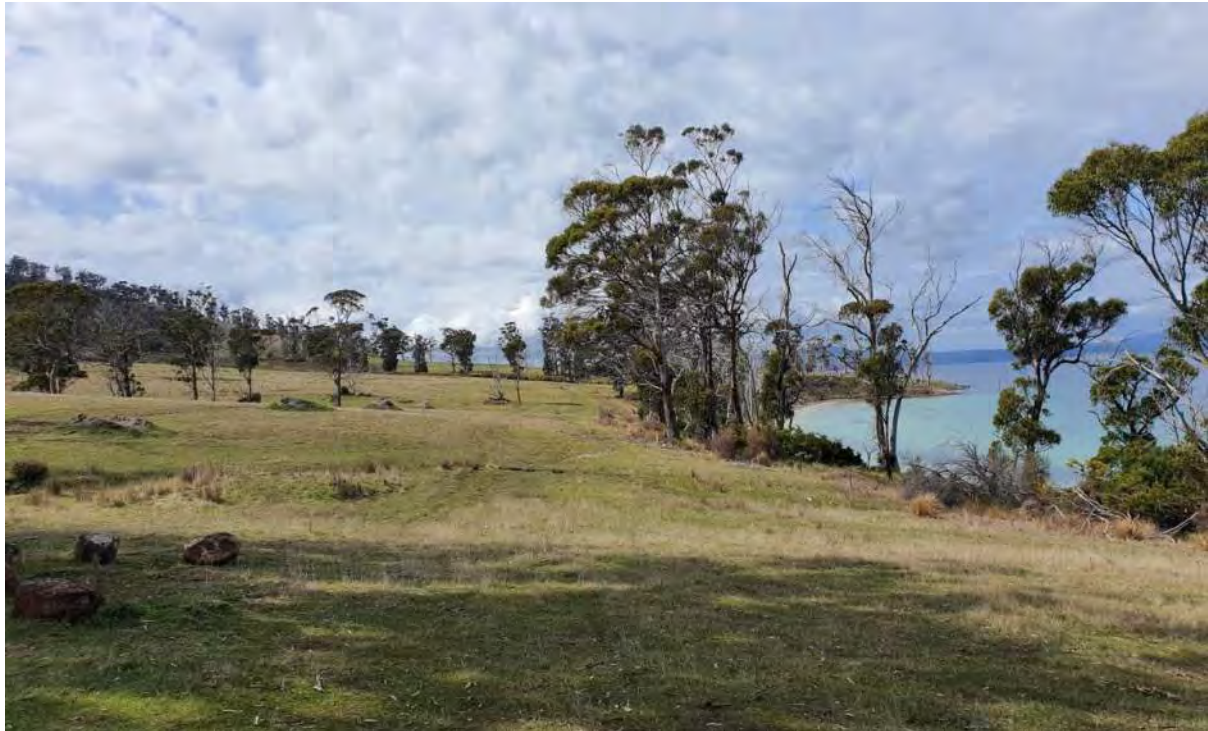
**Figure 3.4b(i) – The western end of the site. Note that the 20m setback is from the title boundary, which is inland from the foreshore.**

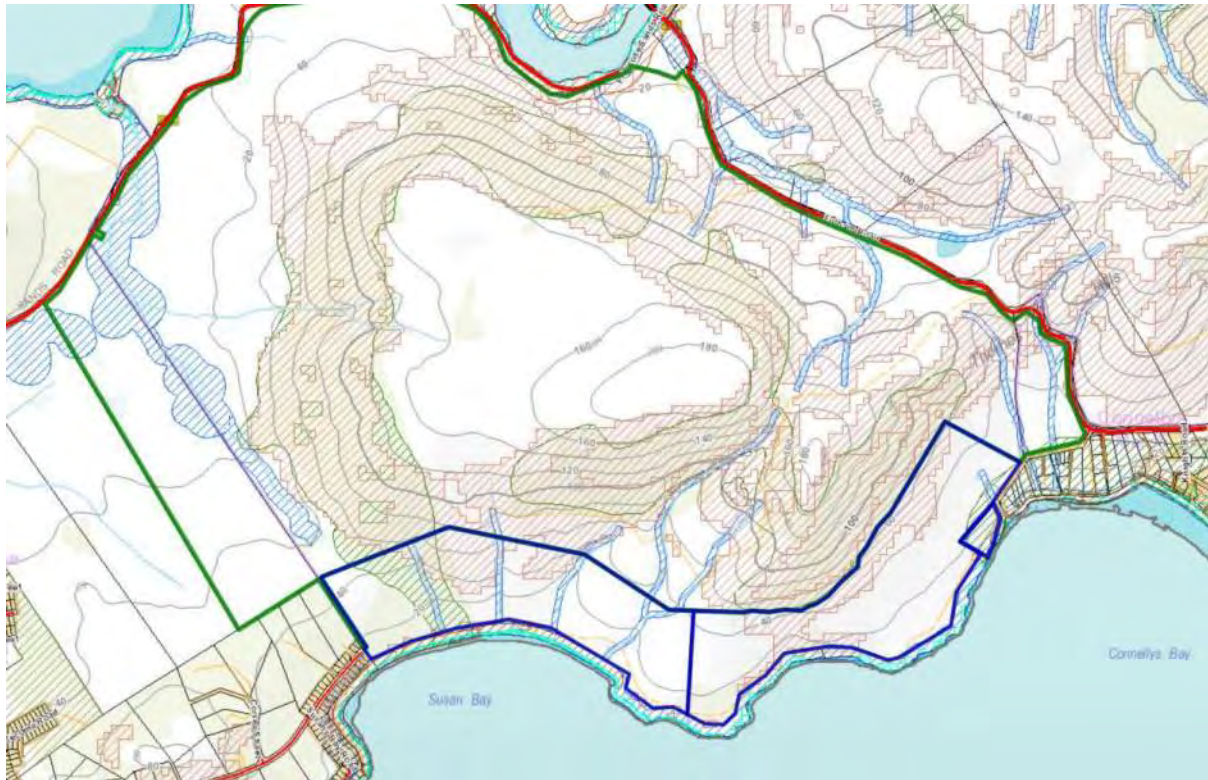
**Map 4.1a** – This map indicates the code overlays in relation to the development site (indicated with the blue flag). The green outline indicates the entire property. The brown hatch is the Landslide Hazard Area, which is mainly low hazard, but with areas of medium hazard. The blue hatched area indicates the 10m buffer required on both sides of a watercourse under the Waterway & Coastal Protection Code and the green hatch area is the Biodiversity Area. The map does not show the Bushfire Prone Area overlay, which covers the entire site. (Source LIST Map)

As shown in Figure 4.1a above, both medium and low risk landslide hazard areas are mapped on the property. These relate principally to the steepness of the hill located in the centre of the property. A strip of Low-level Landslide Hazard Overlay occurs within the development site (Figure 4.3a).

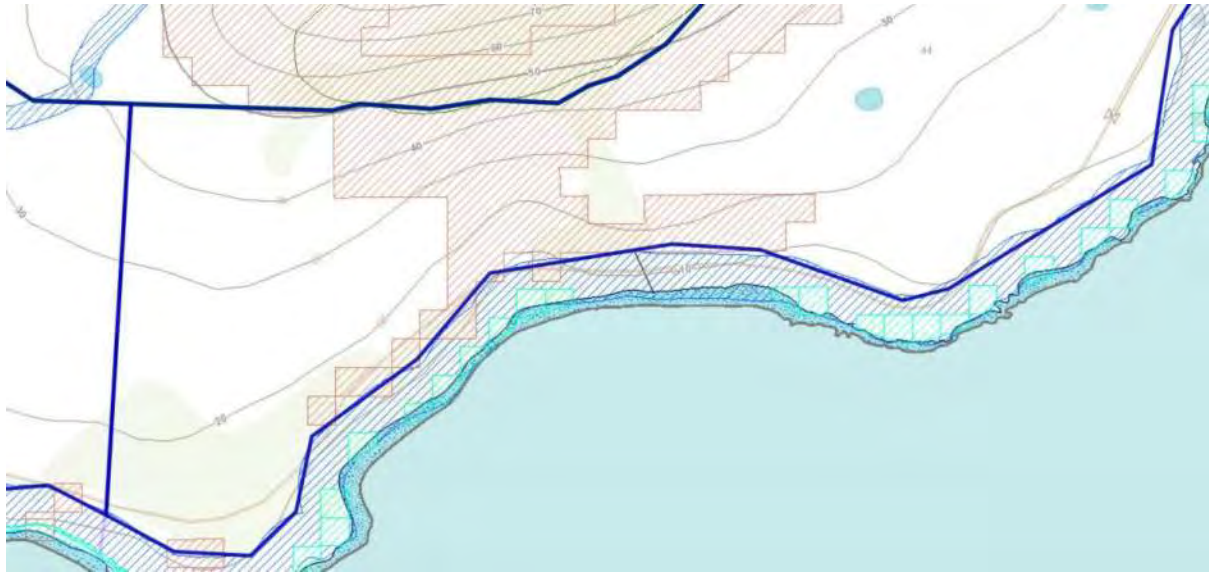
**Figure 4.3a - Low-Level Landslide Hazard Overlay applicable to the site. The proposed Wellness Centre was initially situated within this space, but has been relocated. (Source LIST Map)**

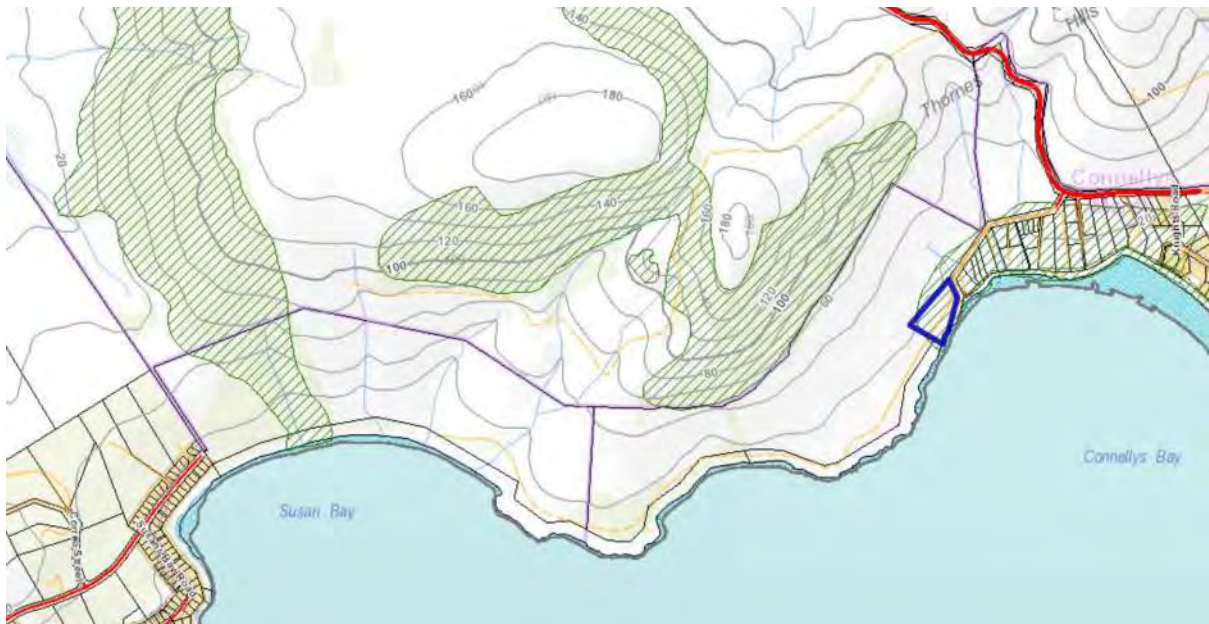
**Figure 4.10a – The hatched green area is the Biodiversity Overlay. Except for the area within the Lot CT: 210947/1 (blue outline) no works or development is to occur within this overlay. (Source LIST Map)**

All land within Lot CT: 210947/1 is mapped to the Biodiversity Overlay, however the TasVeg Layers (LIST Map) cite this area as vegetation type Agricultural Land (FAG). A site inspection has confirmed the agricultural character of the lot, which is grazing land devoid of native vegetation. Older aerial images of the site show some tree cover; however, this was destroyed during the 2013 bushfires. The understorey has always been grazing pasture. These on-site observations are consistent with the vegetation map shown at Figure 1.1b of this report and with the images at Figure 1.1b(i).

In accordance with Clause E10.4.1(n) the proposal is exempt from the provisions of the Biodiversity Code as it entails only the “clearance and conversion or disturbance of previously cleared agricultural land”. Whilst there are several mature trees in this vicinity, it is proposed that these trees are to remain in place and that only the areas historically grazed will be subject to the construction of cabins. After construction, the land will not be grazed on a regular basis.

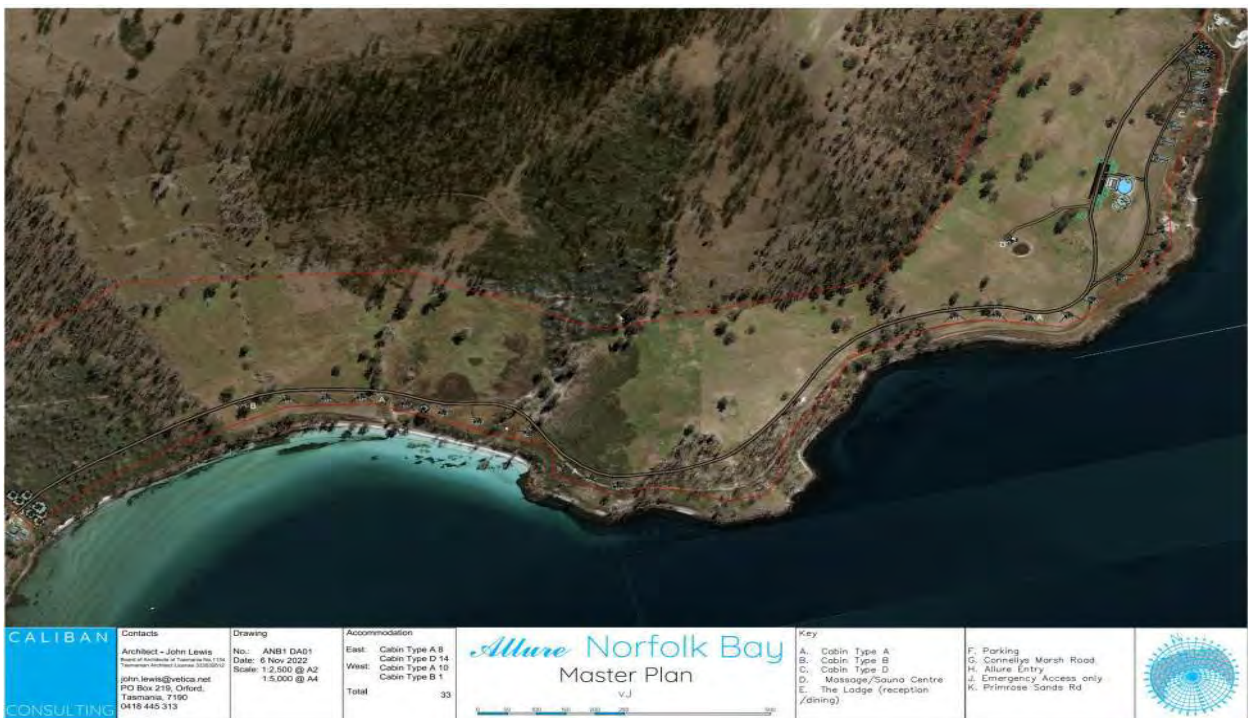
Diagram 3.0 – Map of the accommodation cabins and facilities

The development is for visitor accommodation and includes a total of 32 standalone accommodation cabins that are supported with private facilities including a reception, lounge, and dining space, (the Lodge) massage centre. Each of the cabins will provide self-contained accommodation for two people.

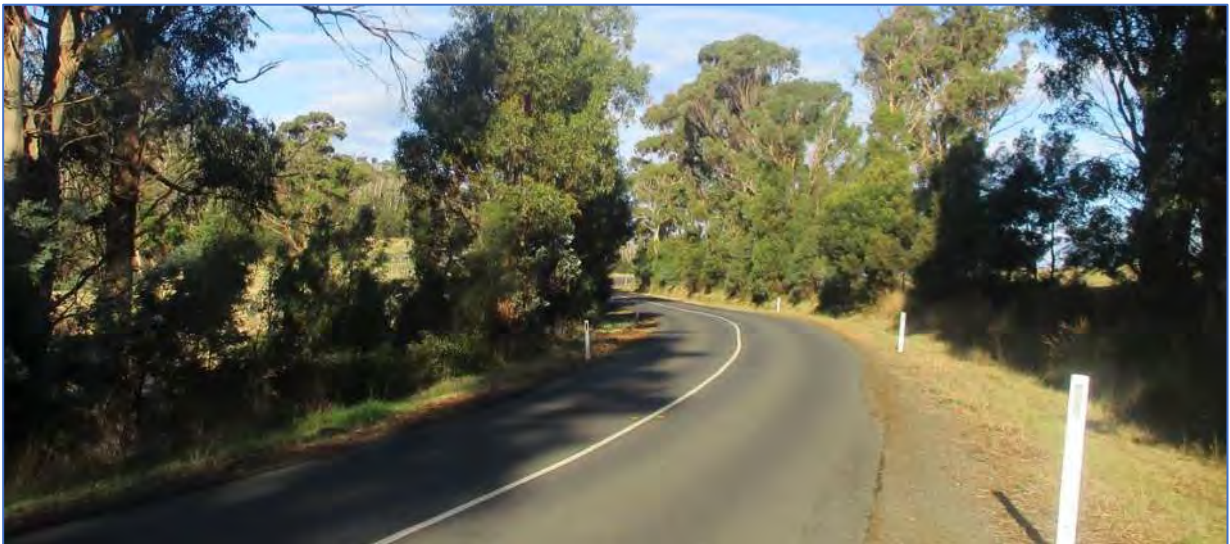
Photograph 5.1 – Typical cross section of Sugarloaf Road

Sugarloaf Road is approximately 8.5 kilometres in length, extending in a southerly direction from the highway and finishing at the junction of Fulham and Primrose Sands Road.

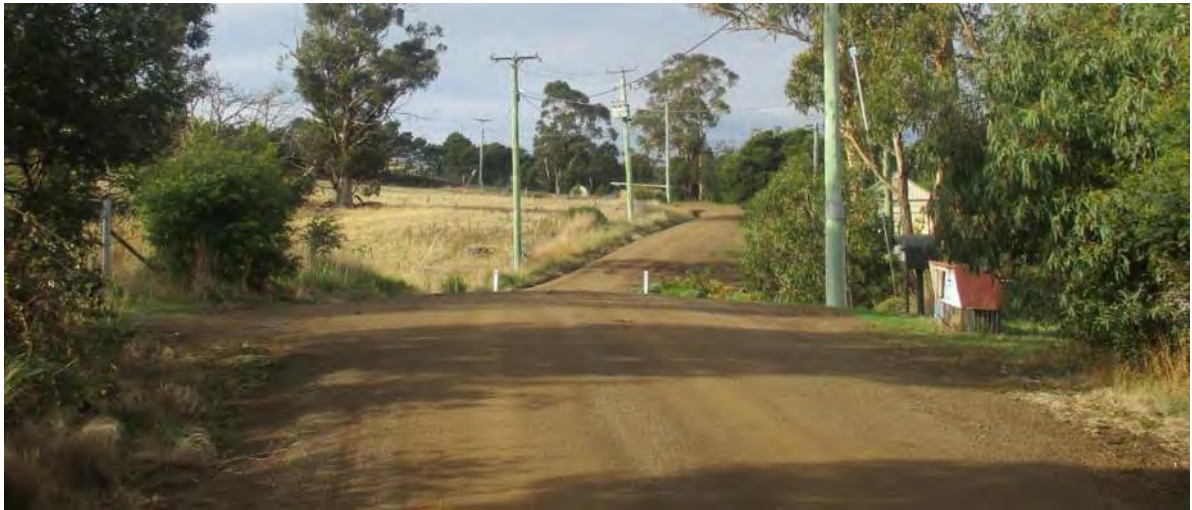
Photograph 5.3A – Demonstrating sight distance to be adequate for opposing vehicles

Forward sight distance between opposing vehicles is reasonable for most of the route (photograph 5.3A), except for one curve where roadside vegetation on the inside of the curve limits sight distance, on the apex of this curve the road width reduces to 3.6 metres due to a significant culvert underneath the road (photograph 5.3B).

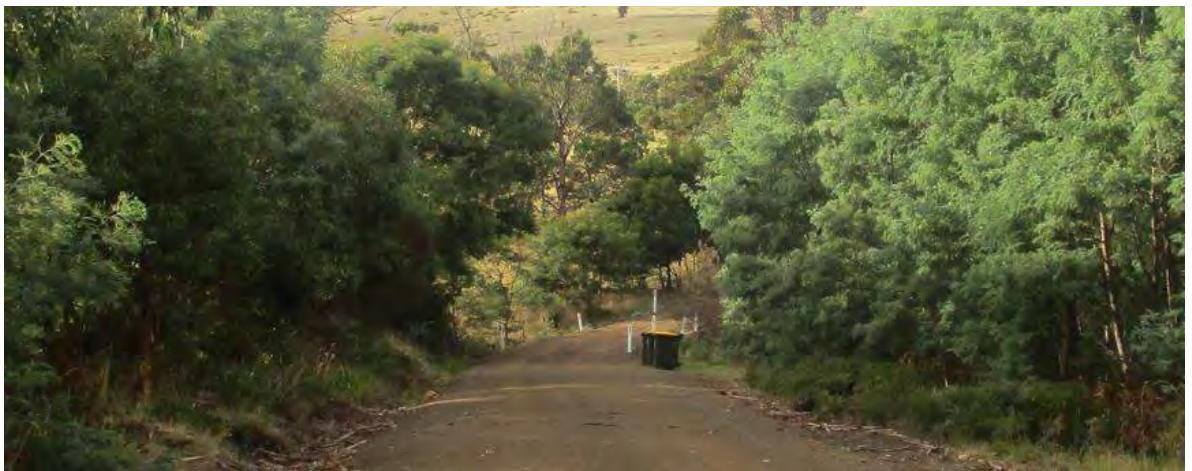
Photograph 5.3B – Demonstrating the vegetation on the inside of curve limiting visibility

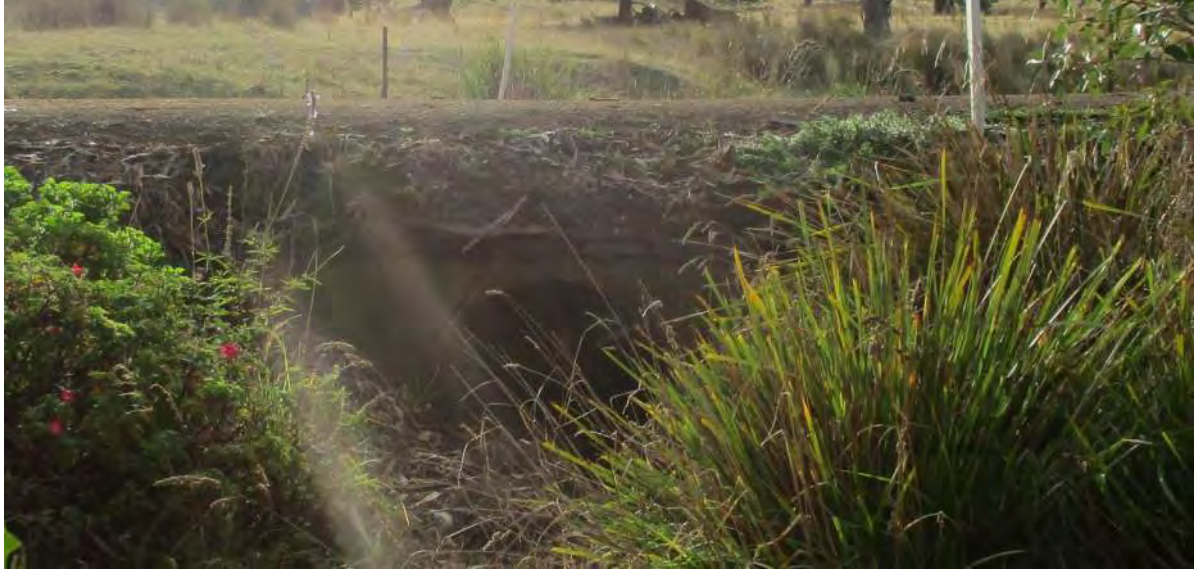
There are three significant culverts that run underneath the road surface, the first culvert consists of a concrete pipe located 185 metres south of Fulham Road, where the culvert narrows the road width to 4.4 metres wide.

Photograph 5.3C – Pipe culvert 185 metres south of Fulham Road

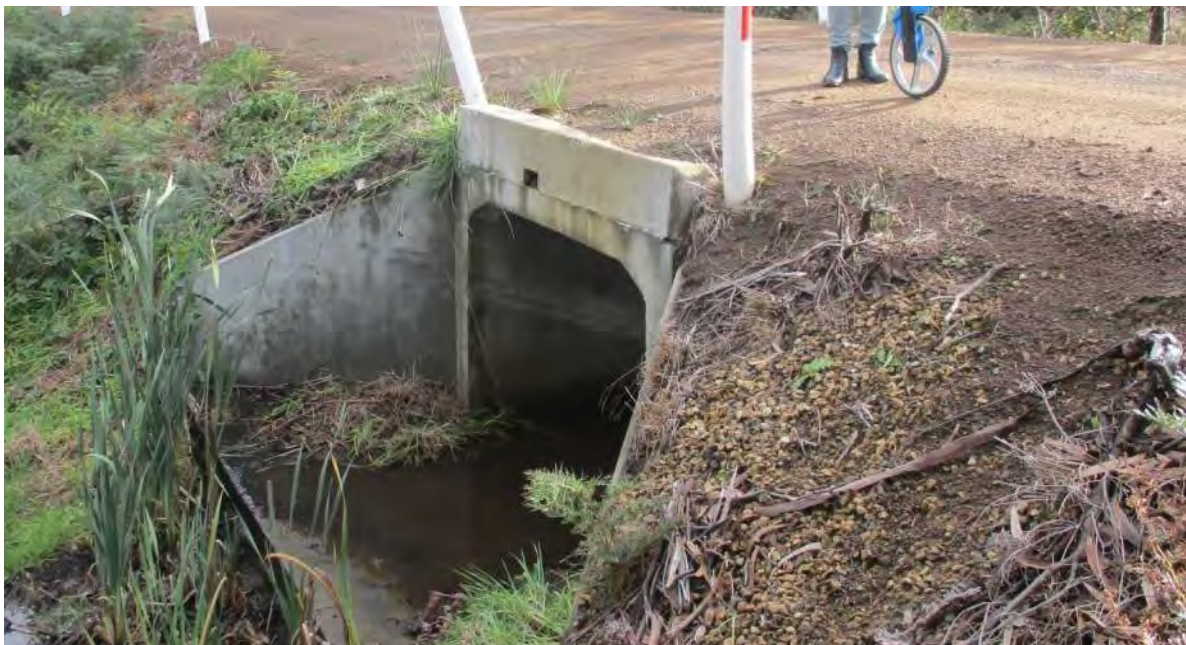
The second culvert is located 260 metres south of Fulham Road and is a concrete box culvert, with a drop that exceeds two metres, and situated on the apex of a horizontal curve, reducing the road width to 3.6 metres wide.

Photograph 5.3D – Box culvert 260 metres south of Fulham Road

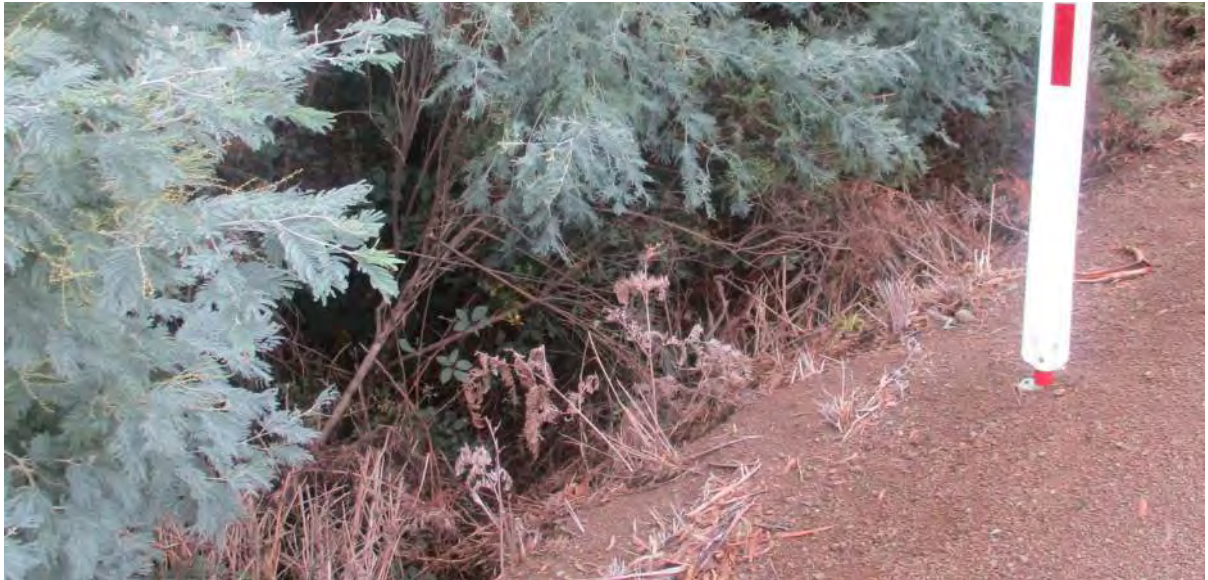
The third culvert is located near the end of the public road, approximately 420 metres south of Fulham Road, and is a pipe culvert that reduces the road width to 3.8 metres. The severity of the culvert is hidden by roadside vegetation.

Photograph 5.3E – Pipe culvert located 420 metres south of Fulham Road

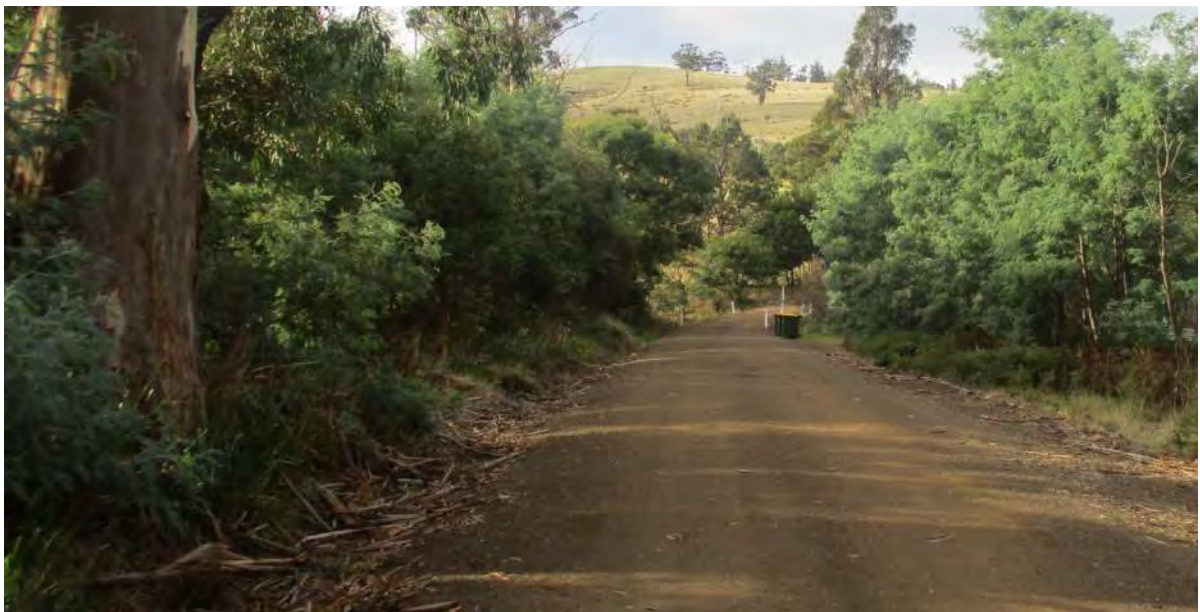
The road reservation (between fence lines) measured around 16 to 18 metres, indicating there is sufficient road reservation for the road to be made two-way. Along the western side there are large established trees adjacent to the road and should road widening be required; the eastern side would be preferable to limit the impact to established trees.

Photograph 5.4F – Large trees on the western side adjacent to the road

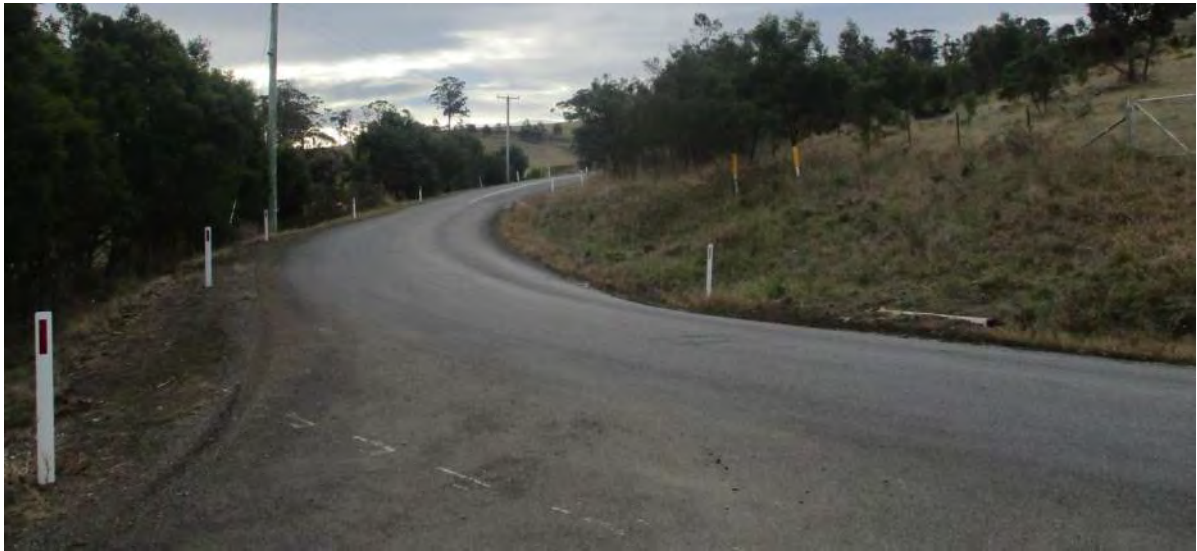
Photograph 5.5A – Available sight distance to the left (120 metres)

Table E5.1 of the planning scheme recommends a SISD of 175 metres for an 80 km/h speed environment. An increase in the available sight distance is achievable through vegetation removal, or sight benching within the council road reserve.

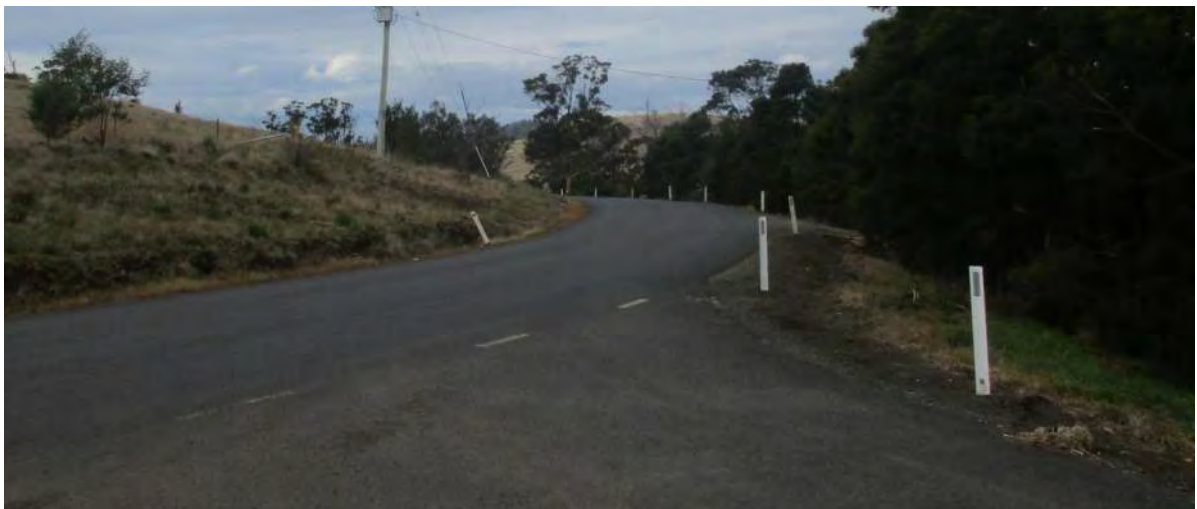
Photograph 5.5B – Available sight distance to the right (157 metres)

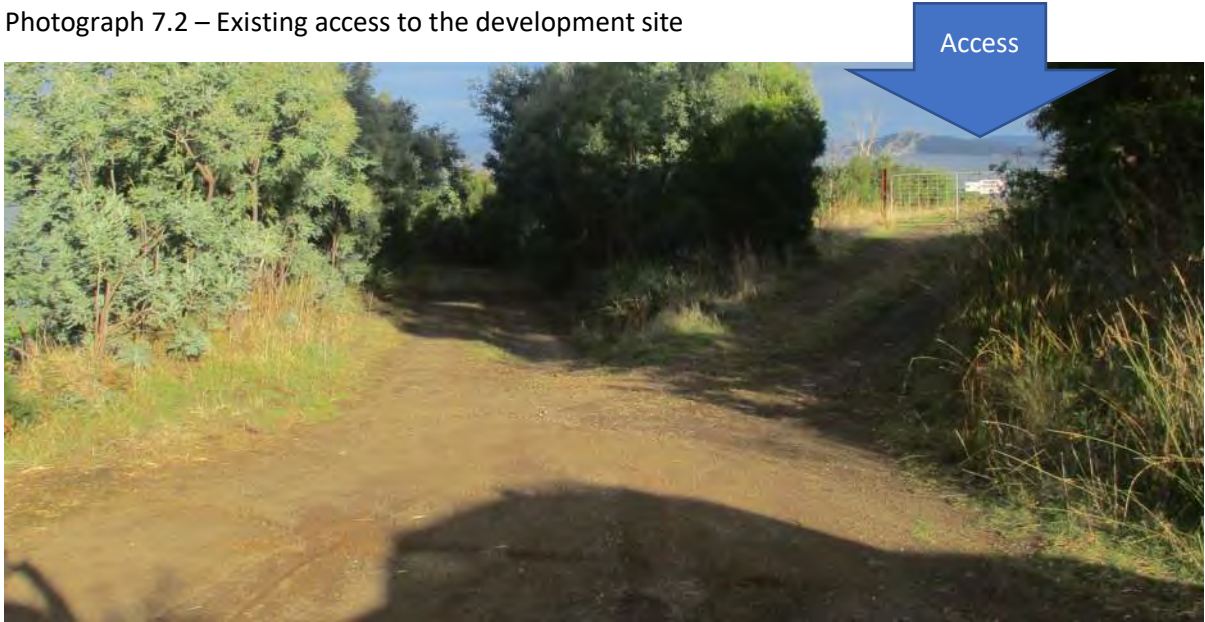
The development 10 is located at the end of Connellys Marsh Road, where there is an existing farm access to the development site, as shown in the photograph below. This access will be repurposed to create a suitable access to accommodate two-way traffic movements.

Photograph 7.2 – Existing access to the development site
