**Revised Nov 2022, Planning Report – Allure Visitor Accommodation at:**

- “Riverside” 297 Primrose Sands Road, Primrose Sands, PID: 9584675 (CT: 181036/19, CT: 181036/20, and CT: 210947/1)

**For: Young-Mundy Property Trust**

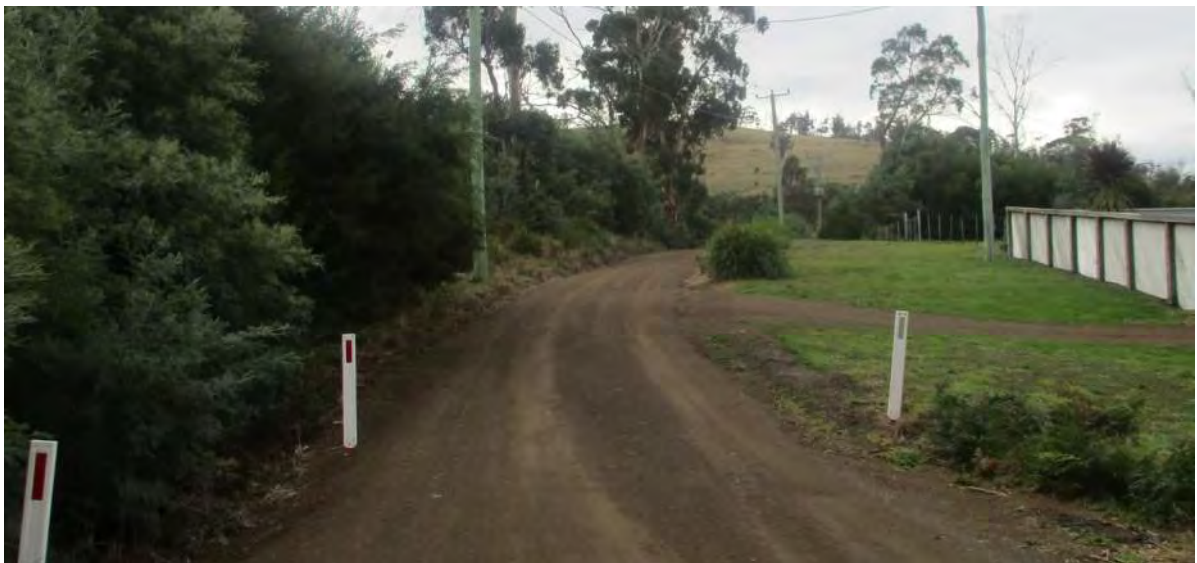
The access to the development site is located at the end of the public road, and vehicles will only approach the access from one direction, with photograph 7.2A showing the available sight distance to approaching vehicles.

Photograph 7.1A – Available sight distance

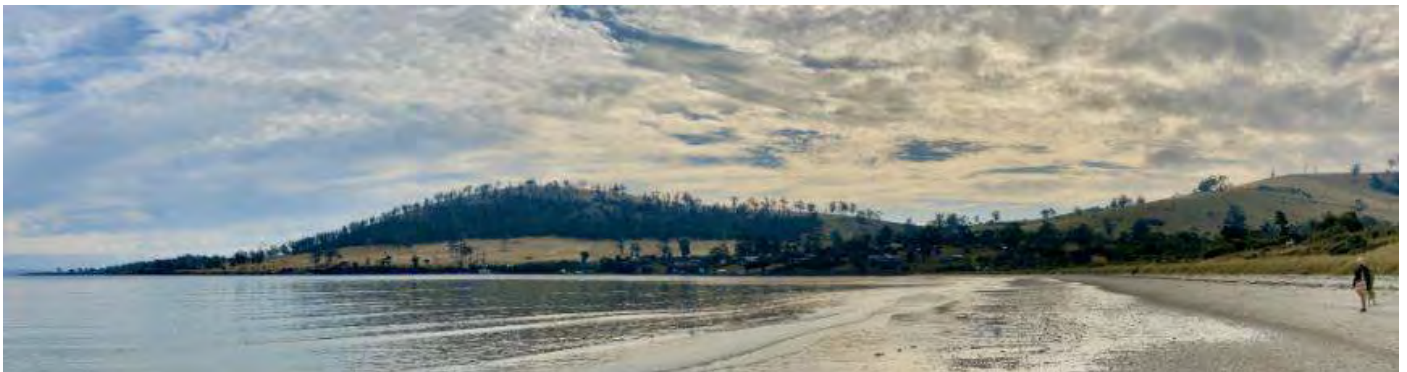
The nearest houses face southwards, away from the site. Those further away, behind the beach, have a more south-westerly aspect, which would include the site, but at a distance of one to two kilometres. Image 2 below illustrates that at this distance, the proposed buildings would be barely visible.

**Image 2: The proposed development from Connellys Marsh Beach**

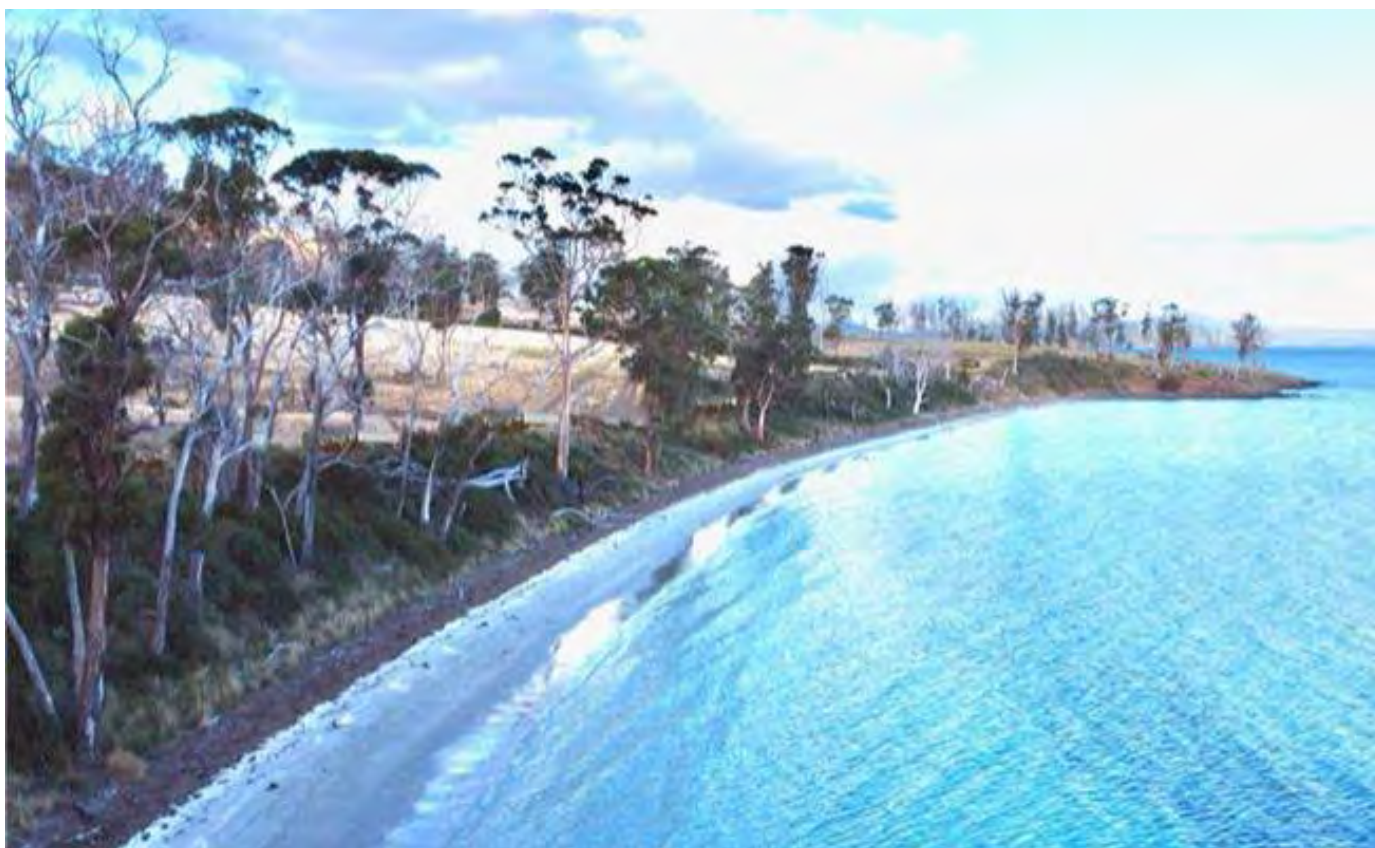
**Image 4: View of proposed development from Susan's Bay Beach**

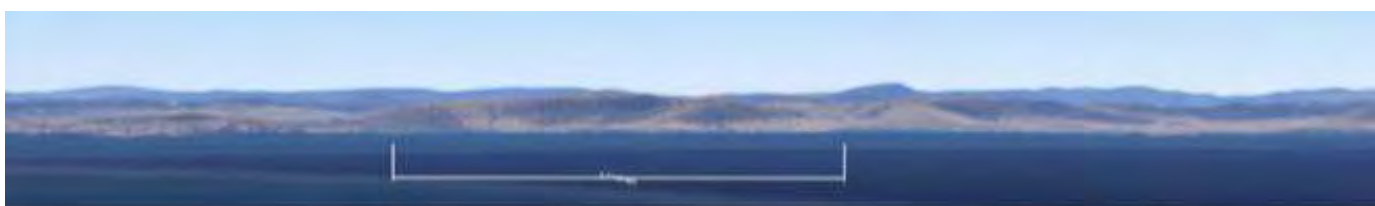
Boats en route to the Dunalley Canal would pass the site at a distance of three kilometres, from which distance there would effectively be no visible presence of the development, as show in Images 5 and 6.

**Image 5: View from a boat approaching Dunalley Canal**

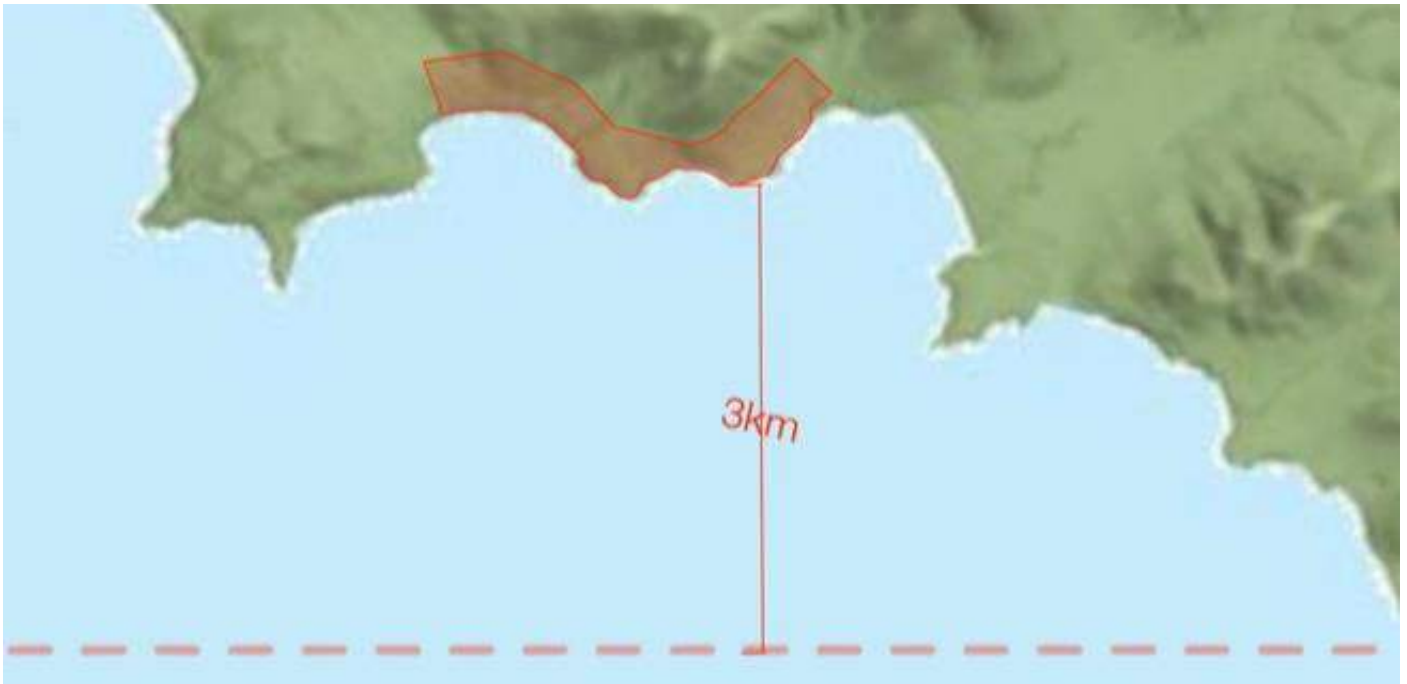
Image 6: Route from the Frederick Henry Bay to the Dunalley Canal (dotted line)

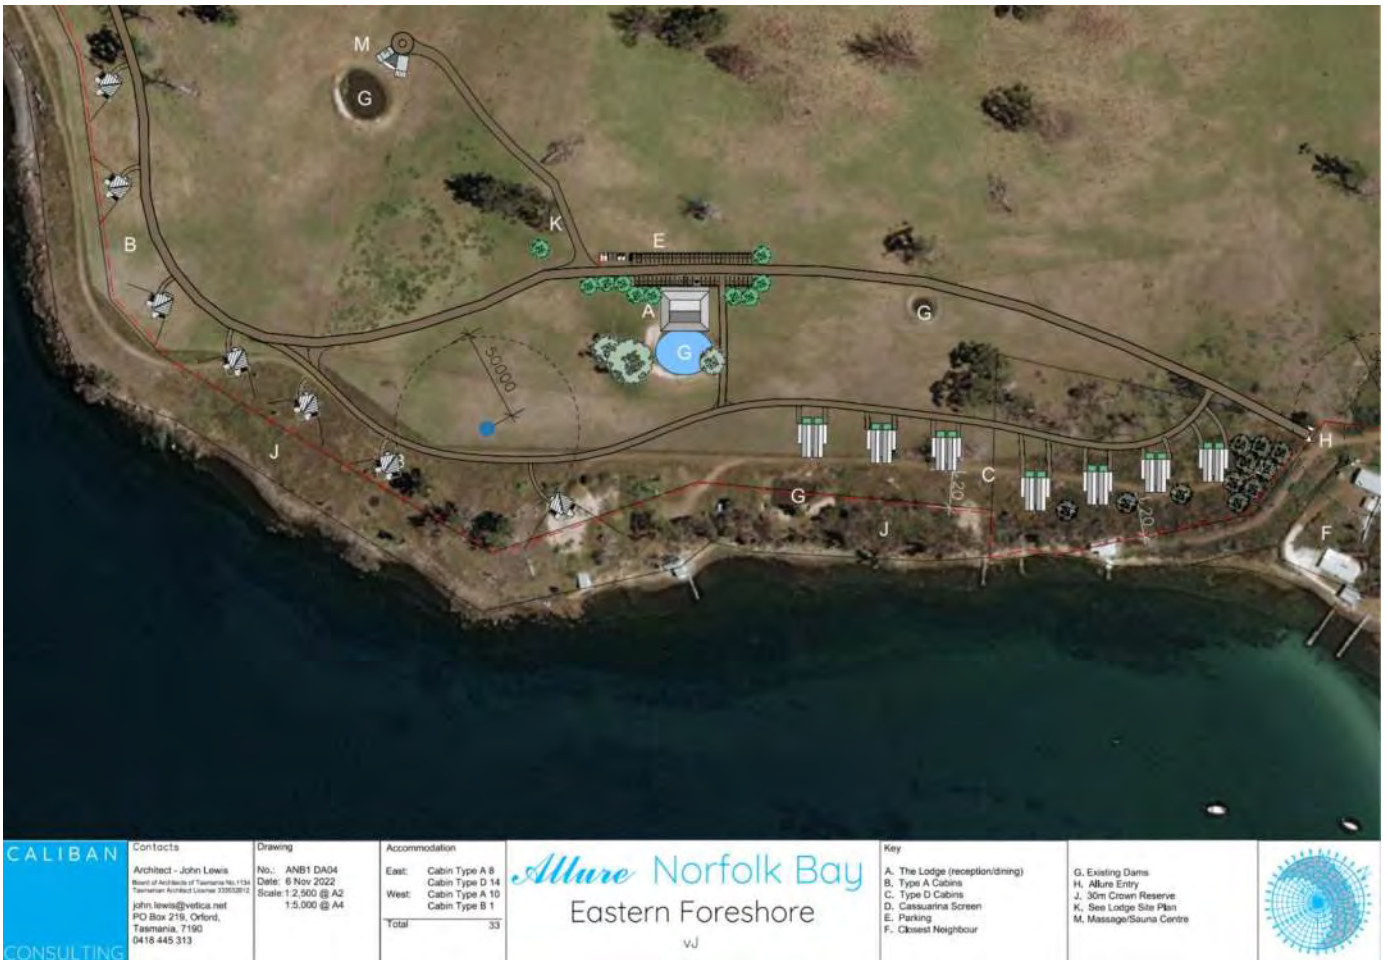
To ensure absolute privacy for all parties, it is planned to establish a screen of *Allocasuarina littoralis* or a similar native species along the eastern border which, when established, would completely screen all the proposed buildings from the near neighbours within four to six years. This screen and the distance separations would also provide noise attenuation.

Image 7: Allure Norfolk Bay eastern border, showing location of nearest neighbour (F)

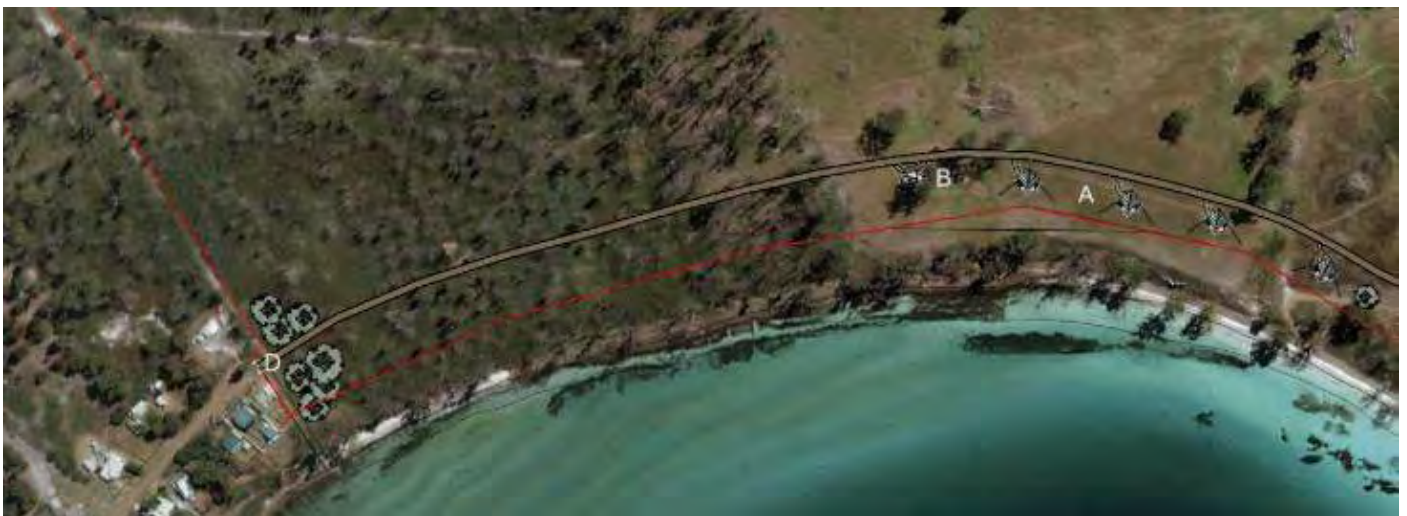
Image 8: Allure Norfolk Bay western border, showing location of nearest neighbours (adjacent to D)

It is proposed that principal access to Allure Norfolk Bay would be from the eastern end of the site, creating minimal impact on the neighbours to the west. A gate would be installed at the end of Primrose Sands Road, for the exclusive purpose of emergency vehicle access. At the western end of the proposed development site, there is approximately 810m between the westernmost Allure cabin and the nearest house (769 Primrose Sands Road). There is an existing strip of bush, which will conceal all proposed Allure buildings from view.

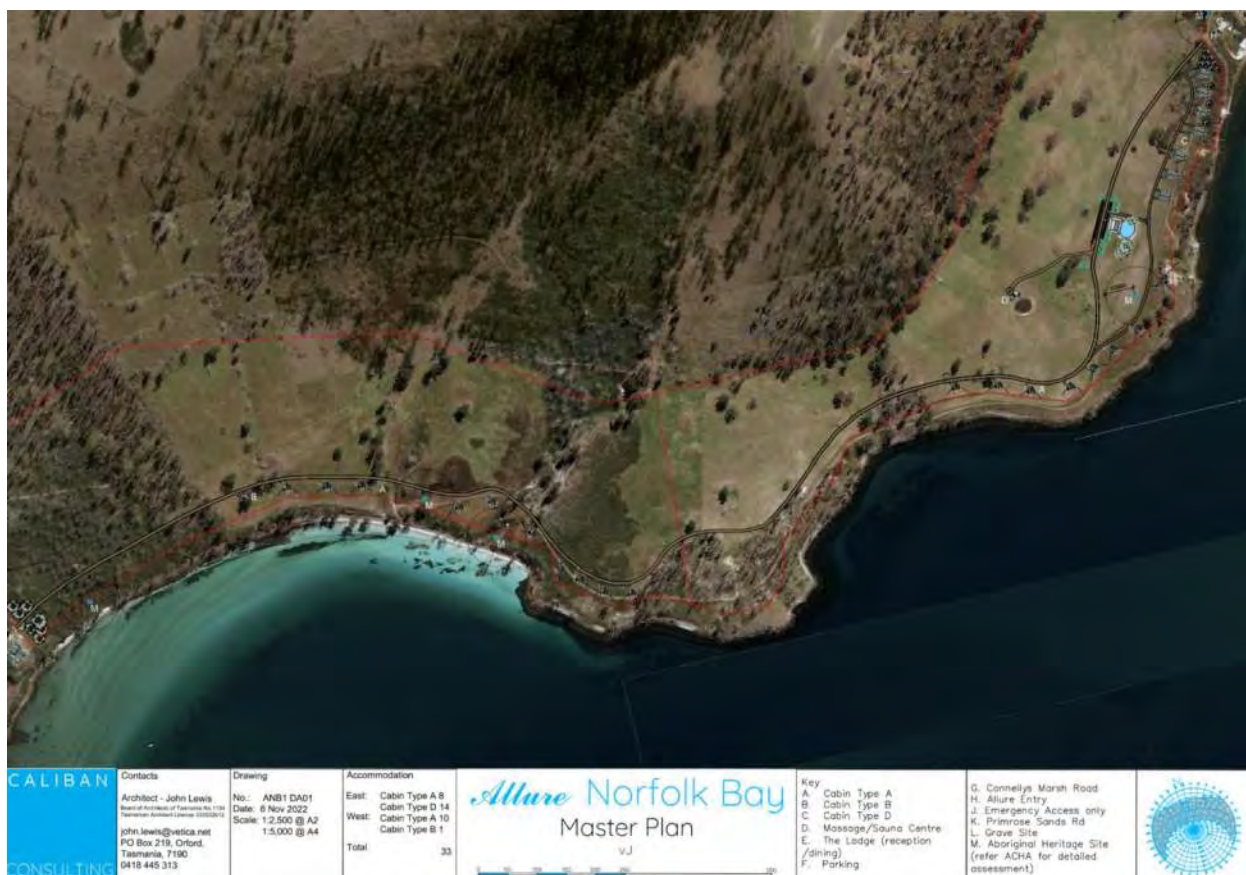
Image 9: Proposed location of buildings, Allure Norfolk Bay

Proposed locations are shown in Image 9.

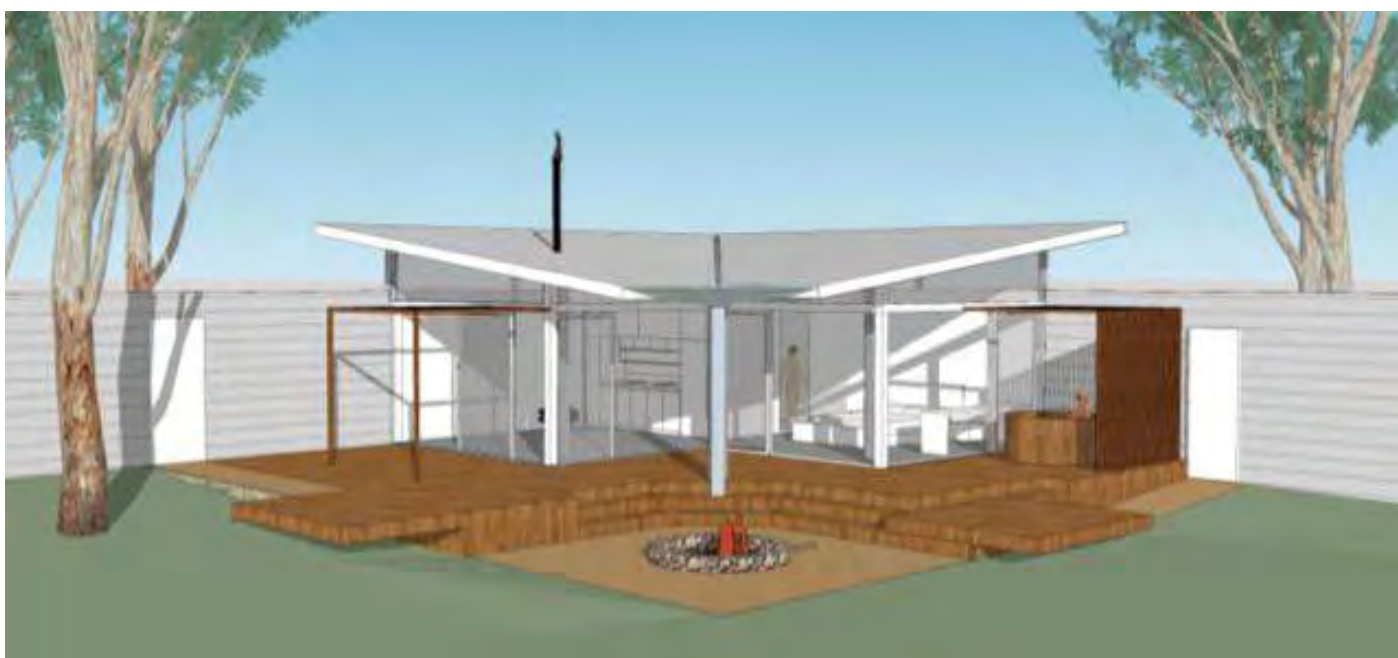
**Image 10: Water-facing view of Type A cabin**

Oriented southwards, each cabin’s highlight windows will flood the interior with sun from the northeast and northwest. All building materials will be local and evocative of the classic Tasmanian coastal ‘Shack’.

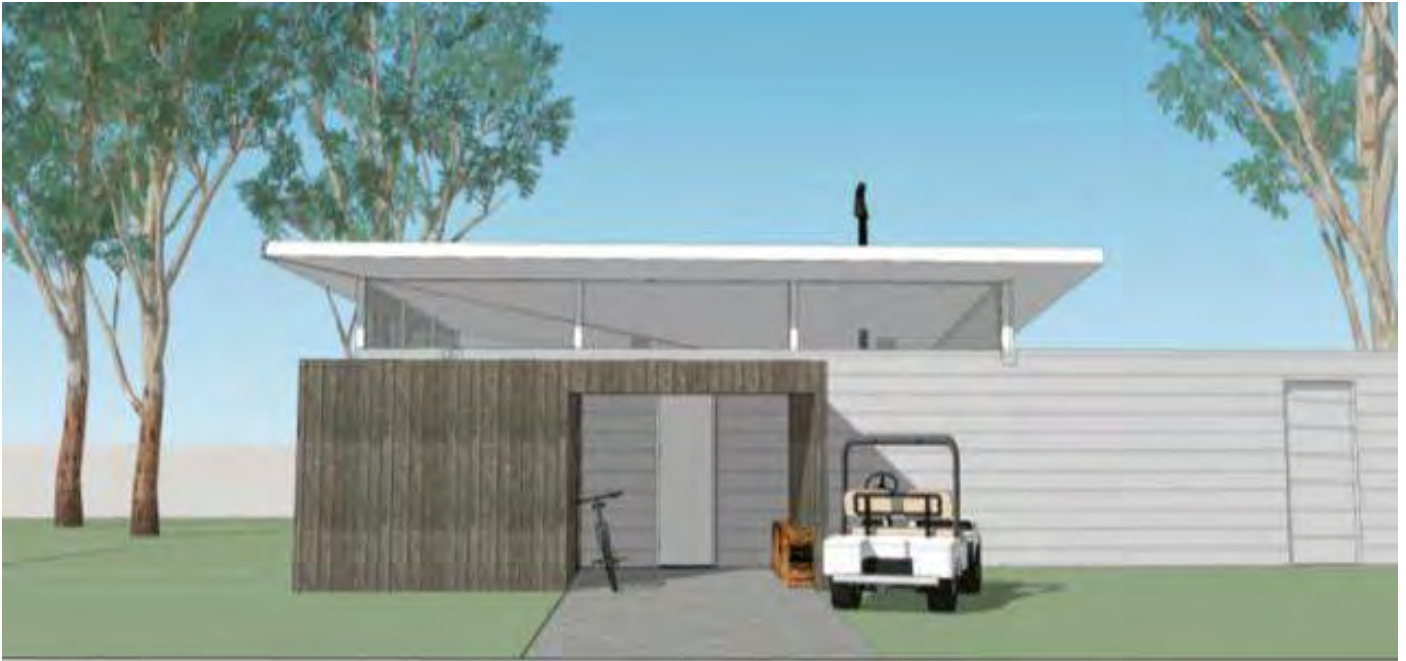
Image 11: Public/roadside view of Type A cabin

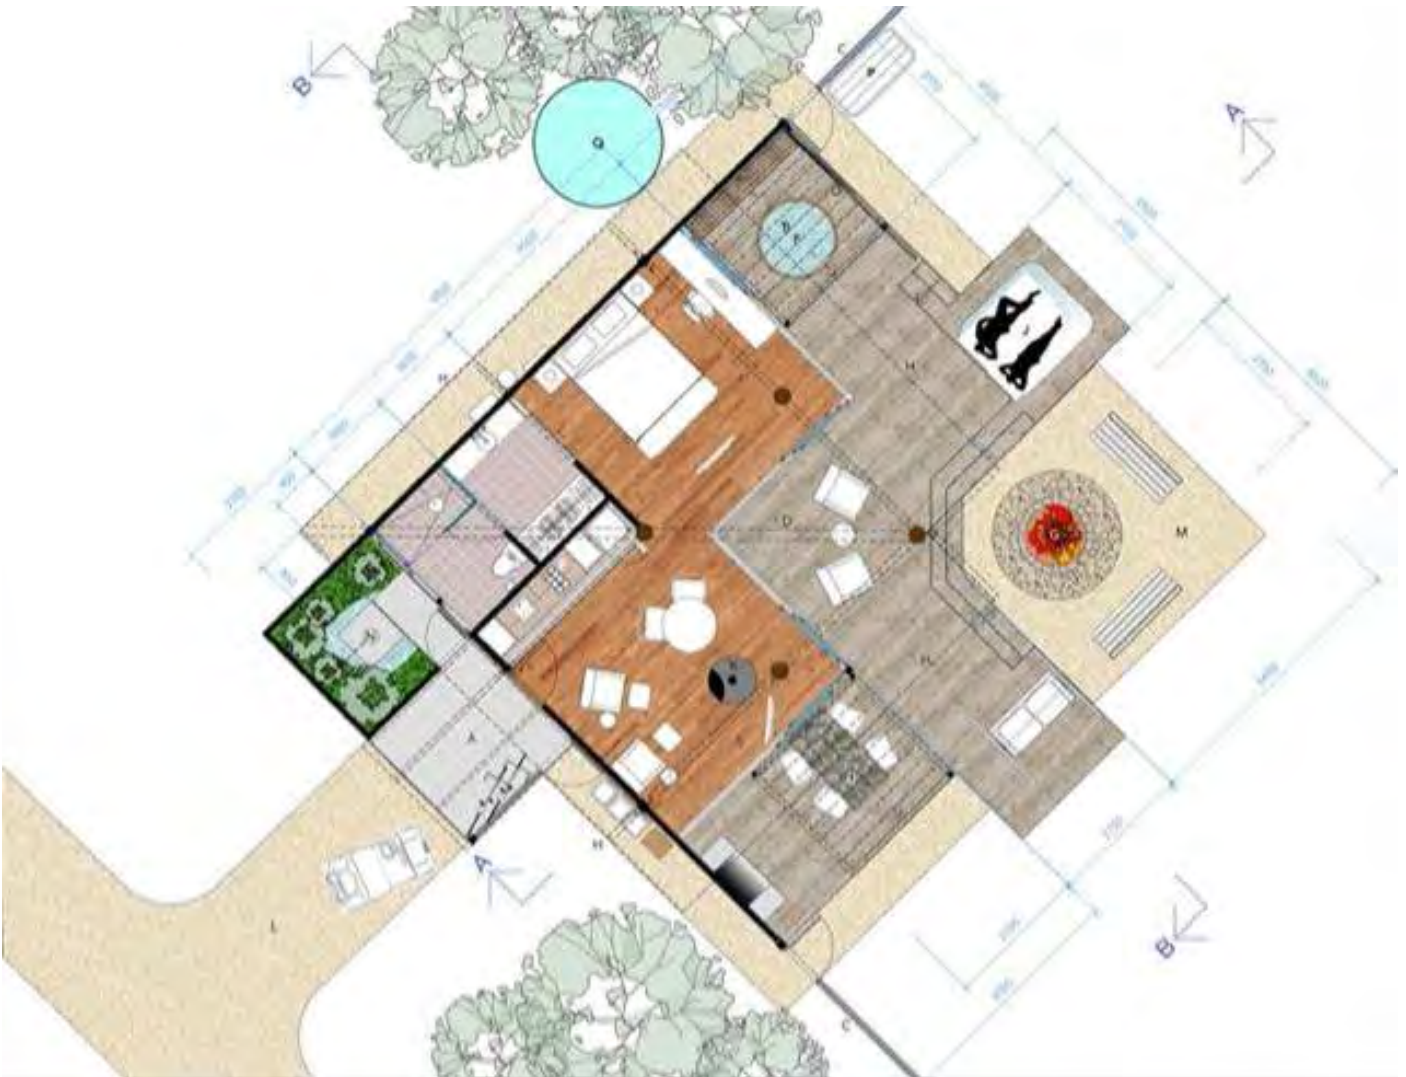
Image 12: Type A cabin floor plan

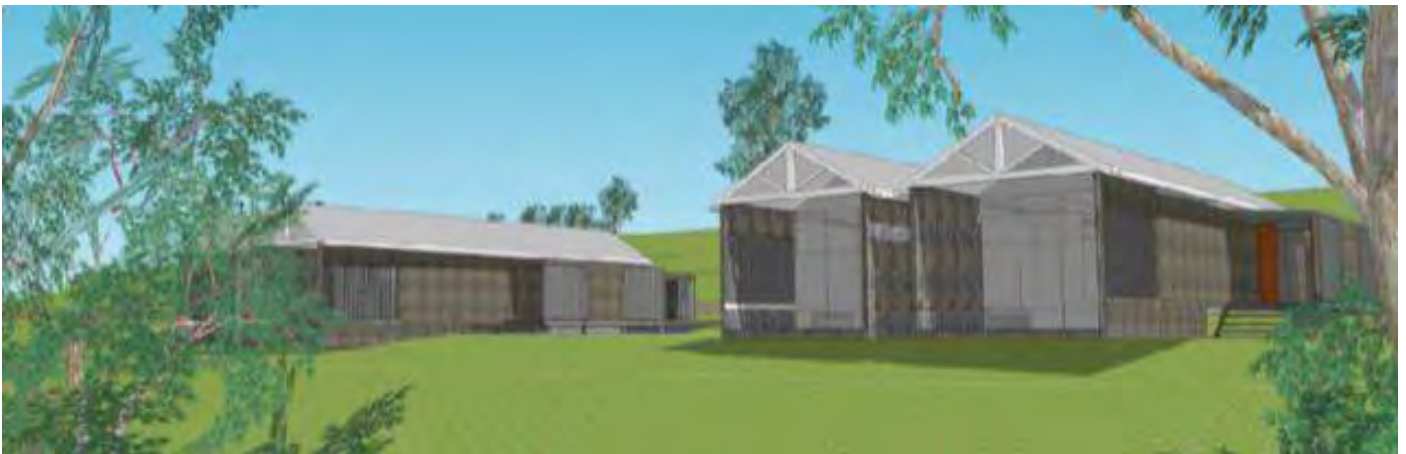
**Image 18: Southern view of Boat Houses (Type D cabins)**

In keeping with the maritime context, these cabins would evoke the characteristic holiday “Shacks” that hug the nooks and crannies of the southeast coast, with simple gable roofs and exposed timber trusses. With their outlook focused on the sea, these cabins would be constructed in pairs along the property’s escarpment, with a party wall of two layers of joinery between them for acoustic privacy. The other side of each cabin would be open, with a mud-room entry, providing a place to store bikes, kayaks or wetsuits.

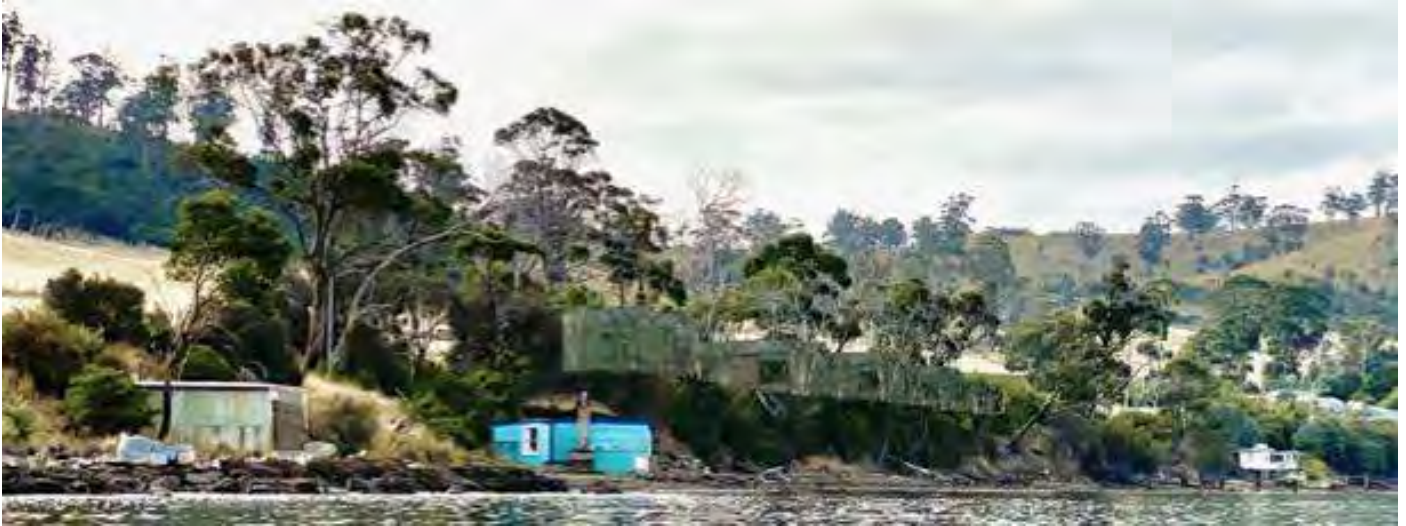
Image 19: View of Boat Houses (Type D cabins) from the water, with existing boat sheds in the foreground

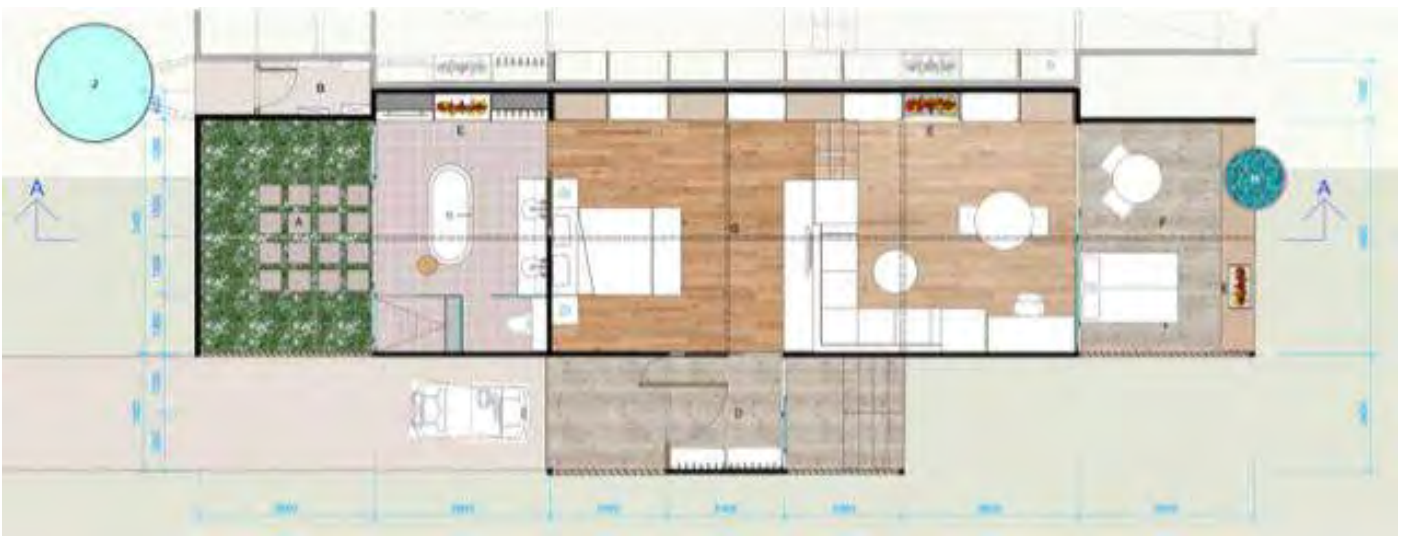
Image 20: Boat House (Type D cabin) floor plan

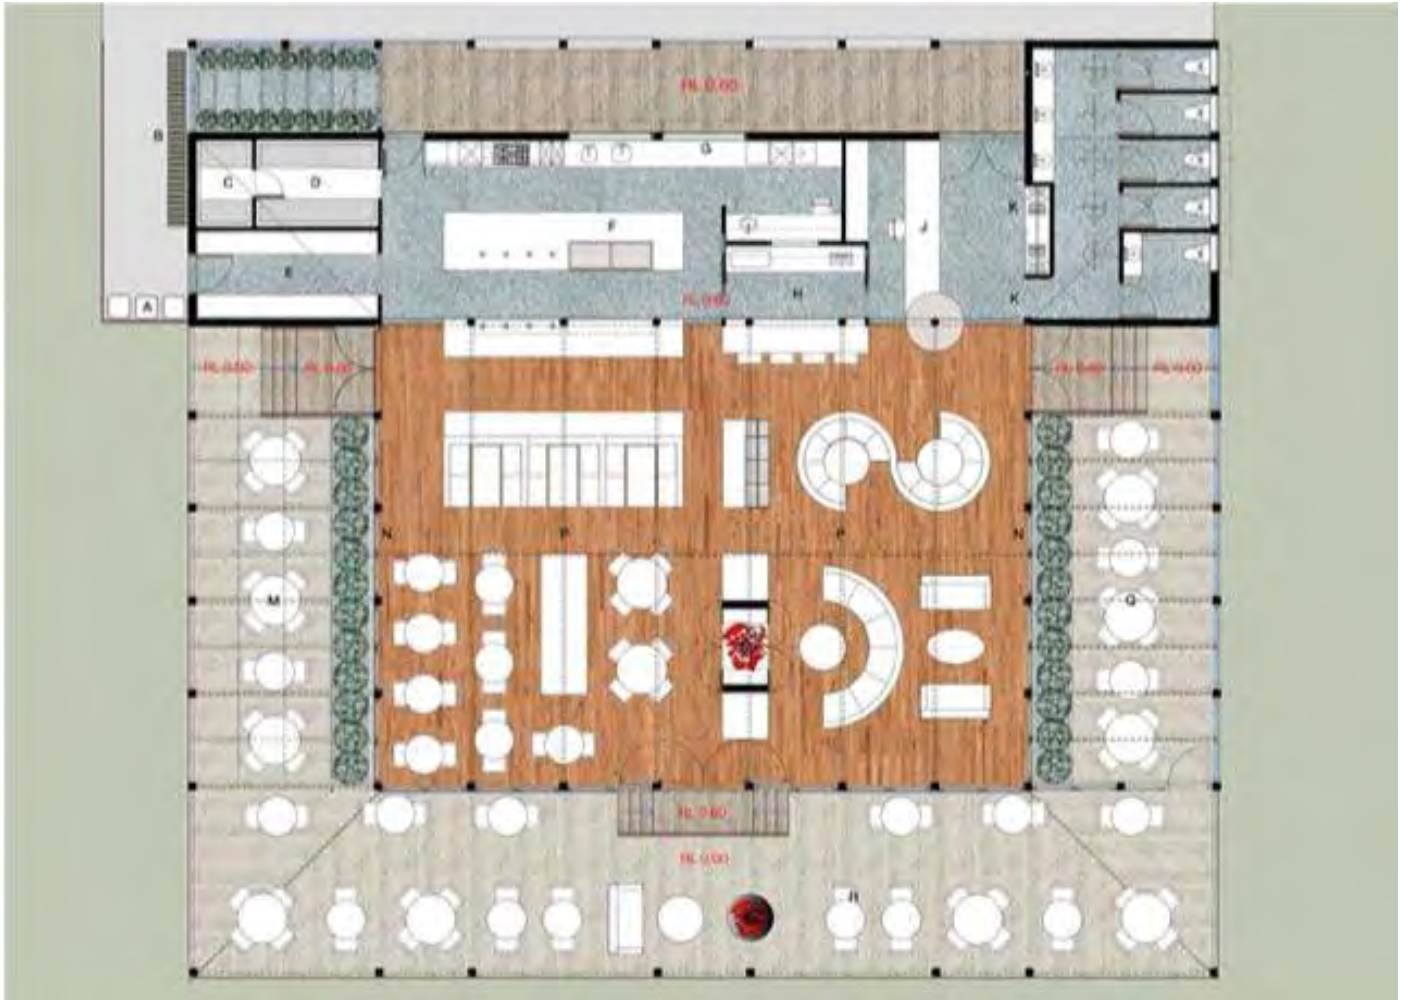
**Image 21: Lodge floor plan**

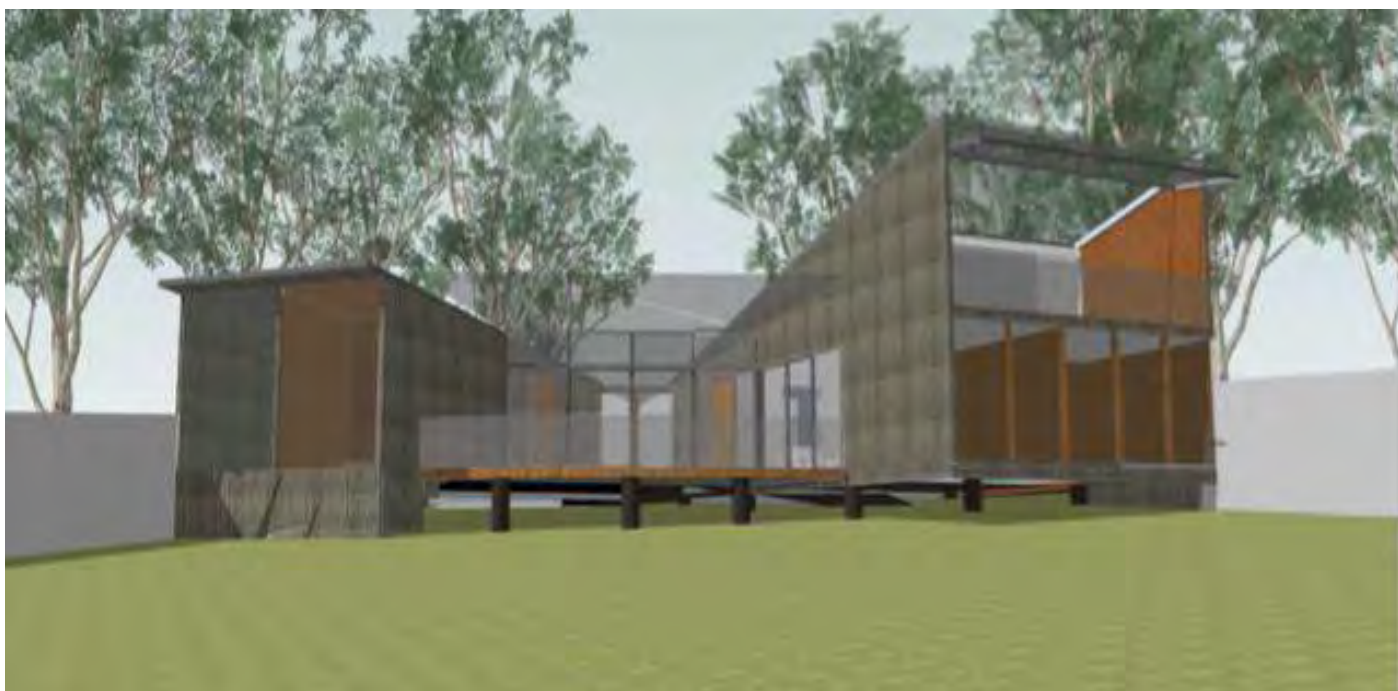
Image 24: View of massage and sauna centre from the south

For the enjoyment of Allure guests, it is also proposed to create a massage and sauna centre overlooking Norfolk Bay. The centre will incorporate a meditation garden and sauna.

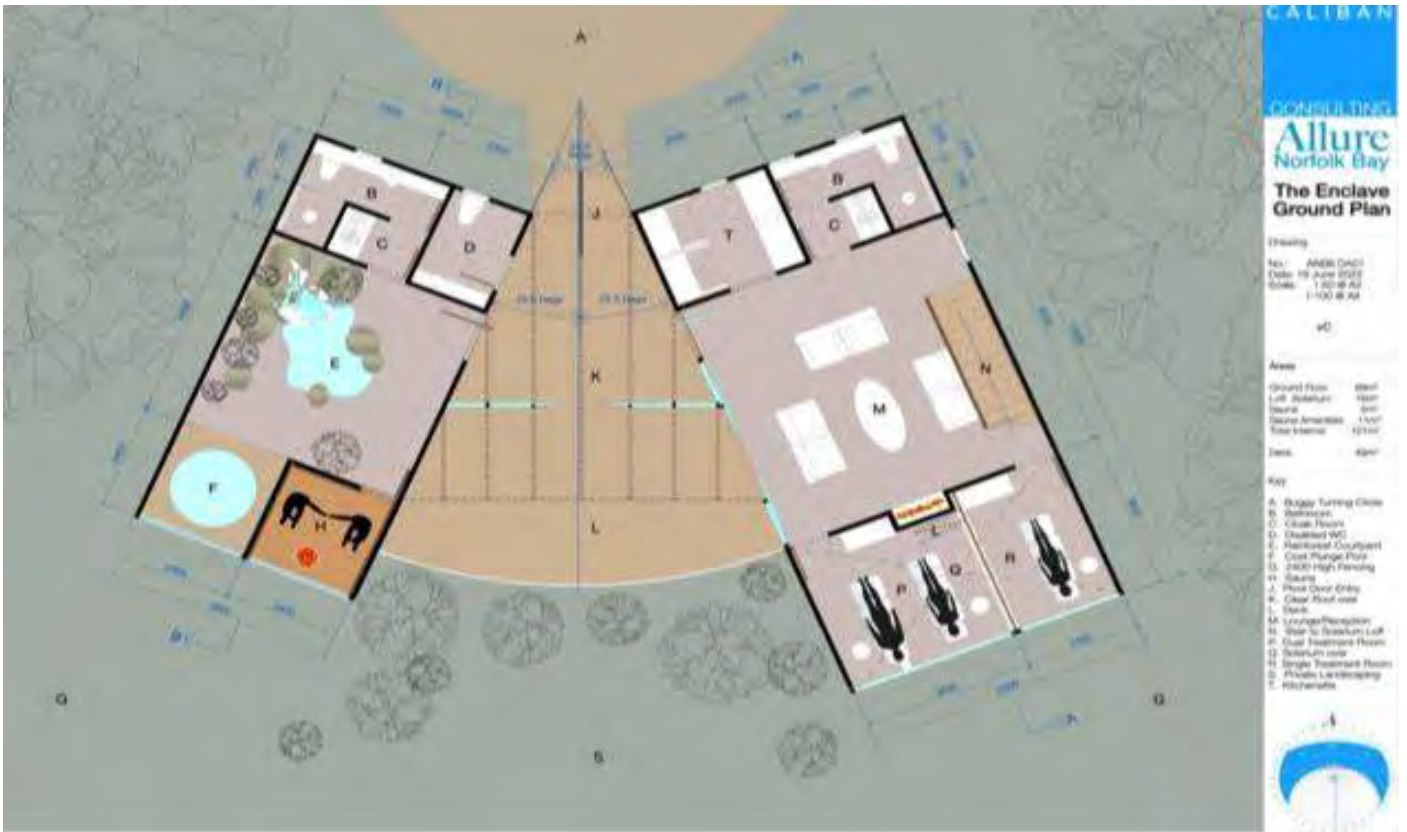
Image 25: Massage and sauna centre floor plan

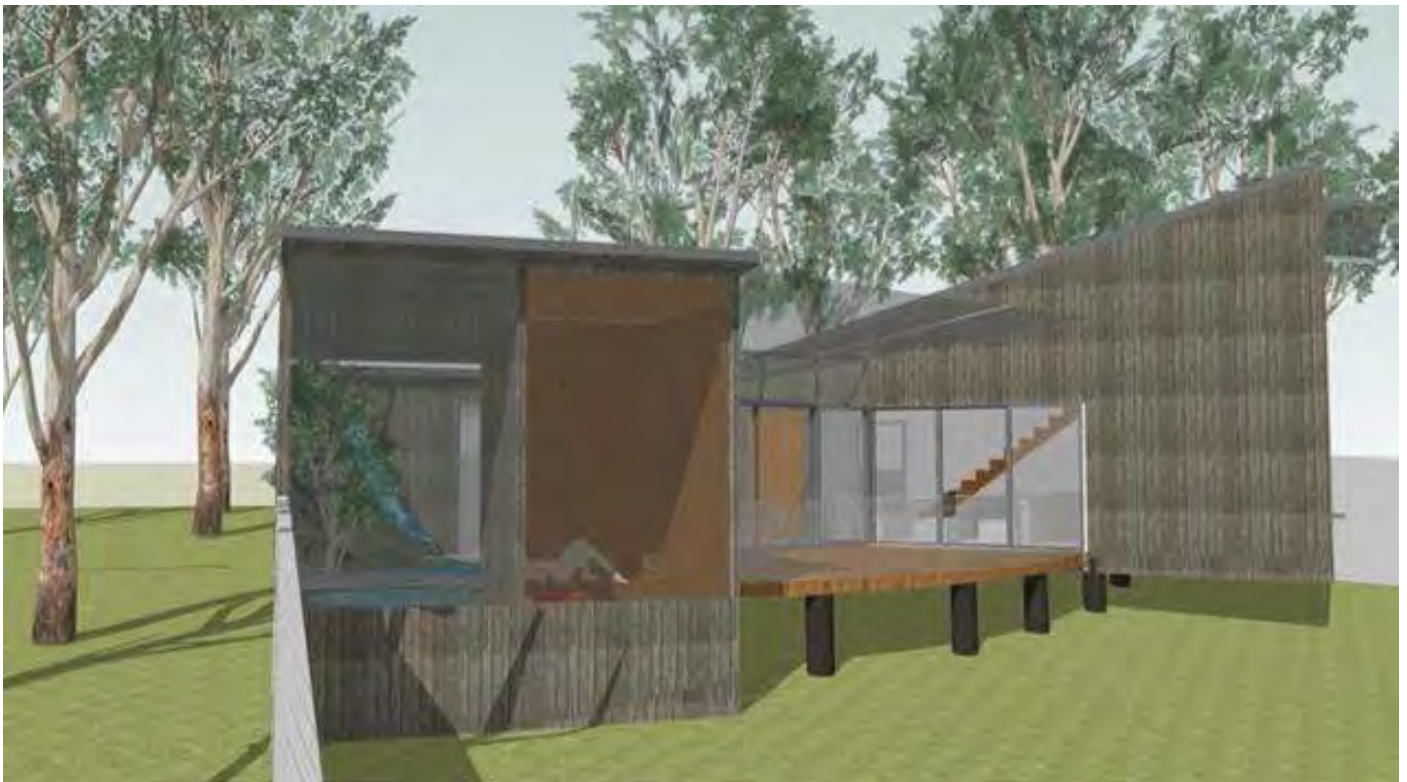
Image 26: View of massage and sauna centre from the east, showing private rooms with solarium

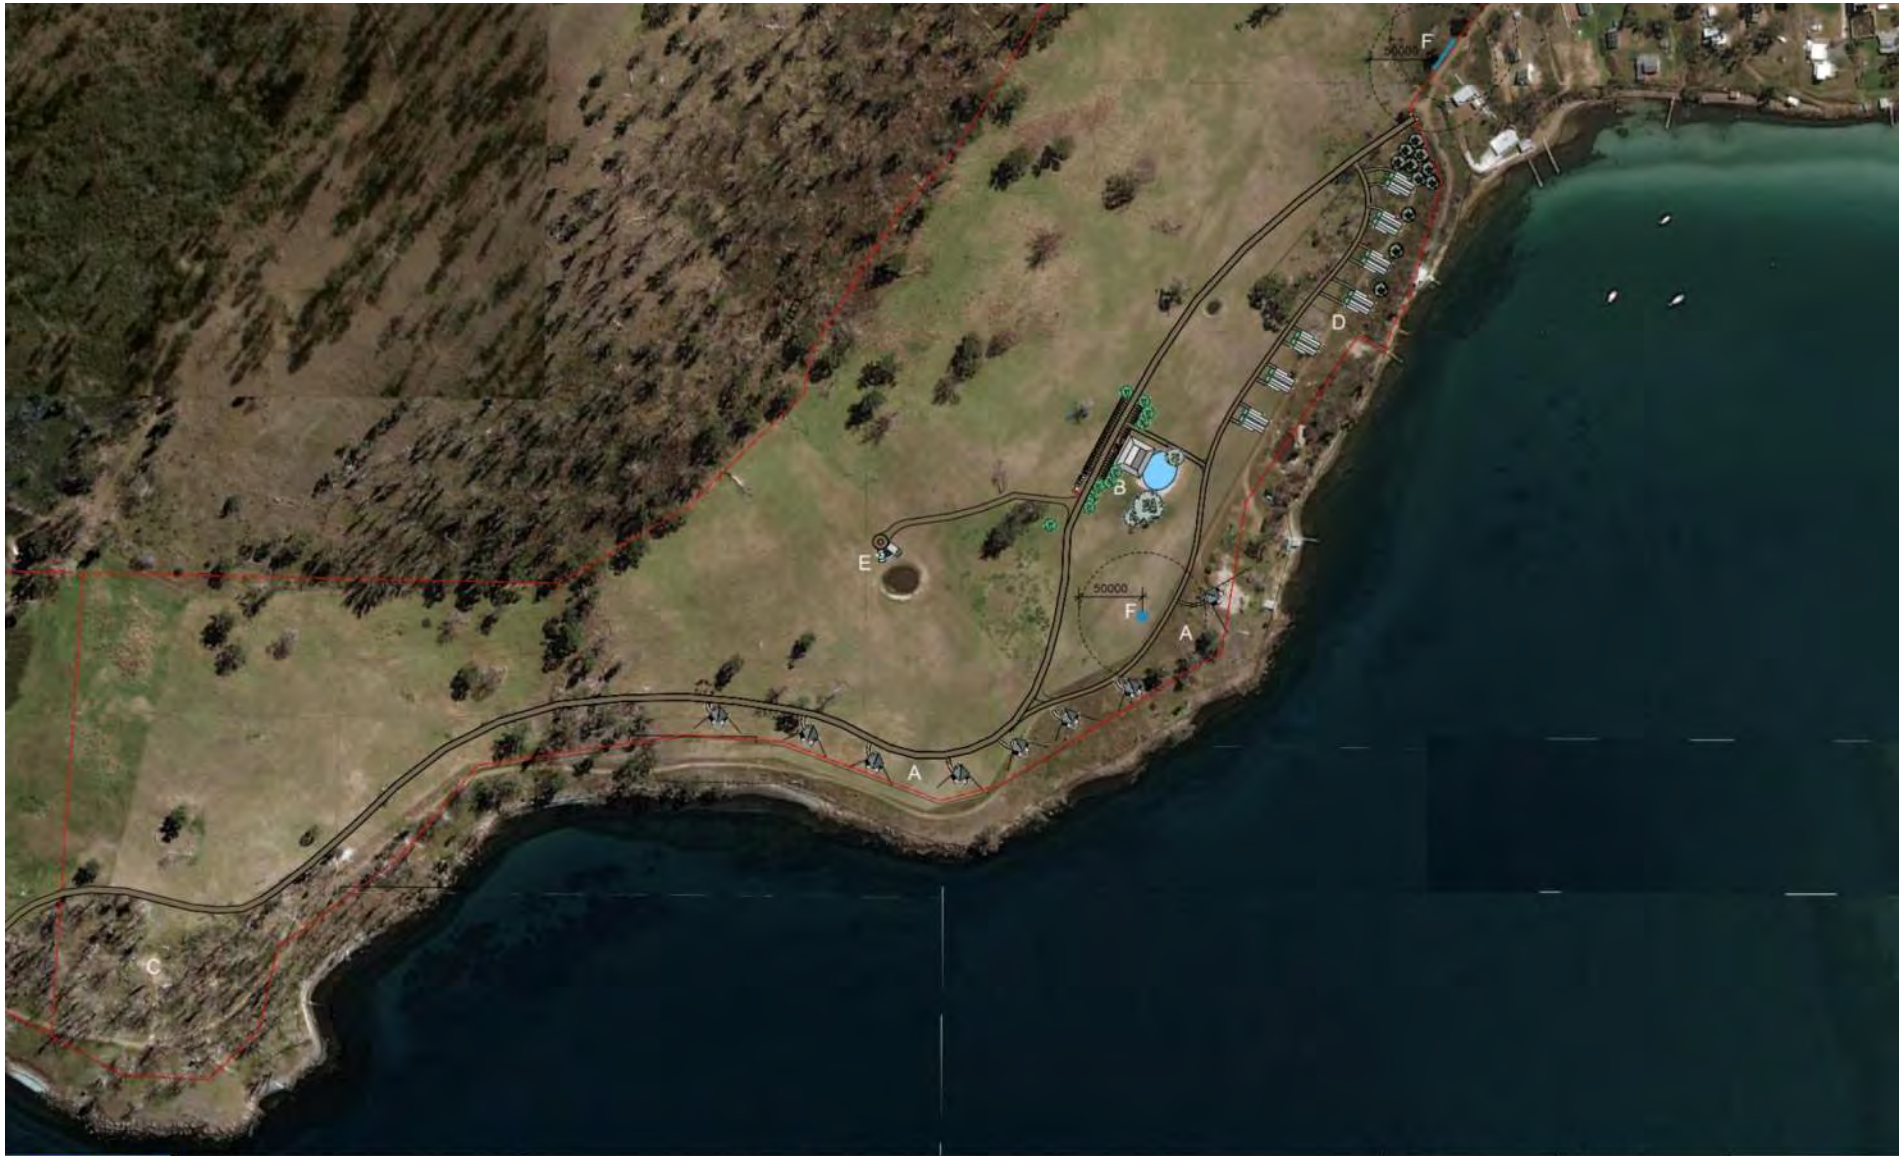
Image 28: Allure Norfolk Bay Master Plan, East

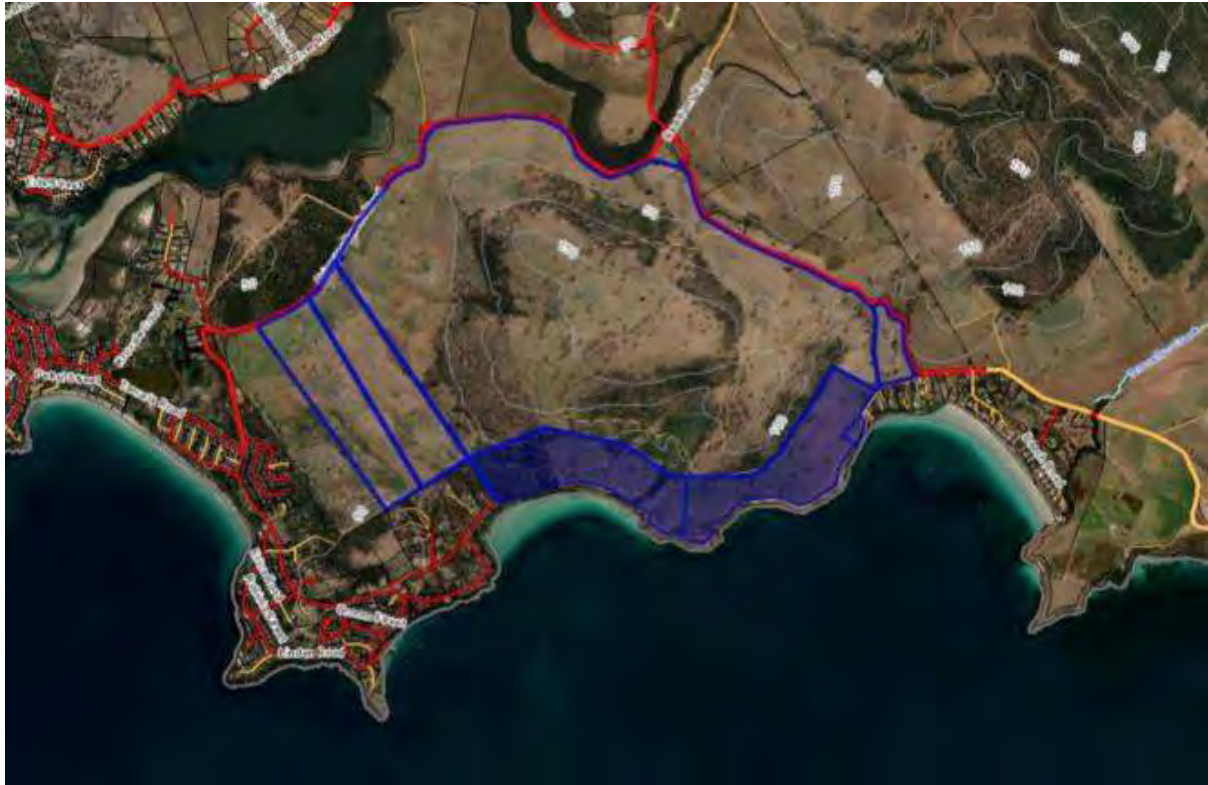
Image 1: “Riverside”, 297 Primrose Sands Road, Primrose Sands (PID: 9584675) in blue outline. The area of the proposed development is restricted to the section shaded blue. (Source LIST Map)

The proposed development is limited to approximately 10 hectares on the southern boundary of the property, overlooking Norfolk Bay and including the following lots:
