**Revised Nov 2022, Planning Report – Allure Visitor Accommodation at:**

- “Riverside” 297 Primrose Sands Road, Primrose Sands, PID: 9584675 (CT: 181036/19, CT: 181036/20, and CT: 210947/1)

**For: Young-Mundy Property Trust**

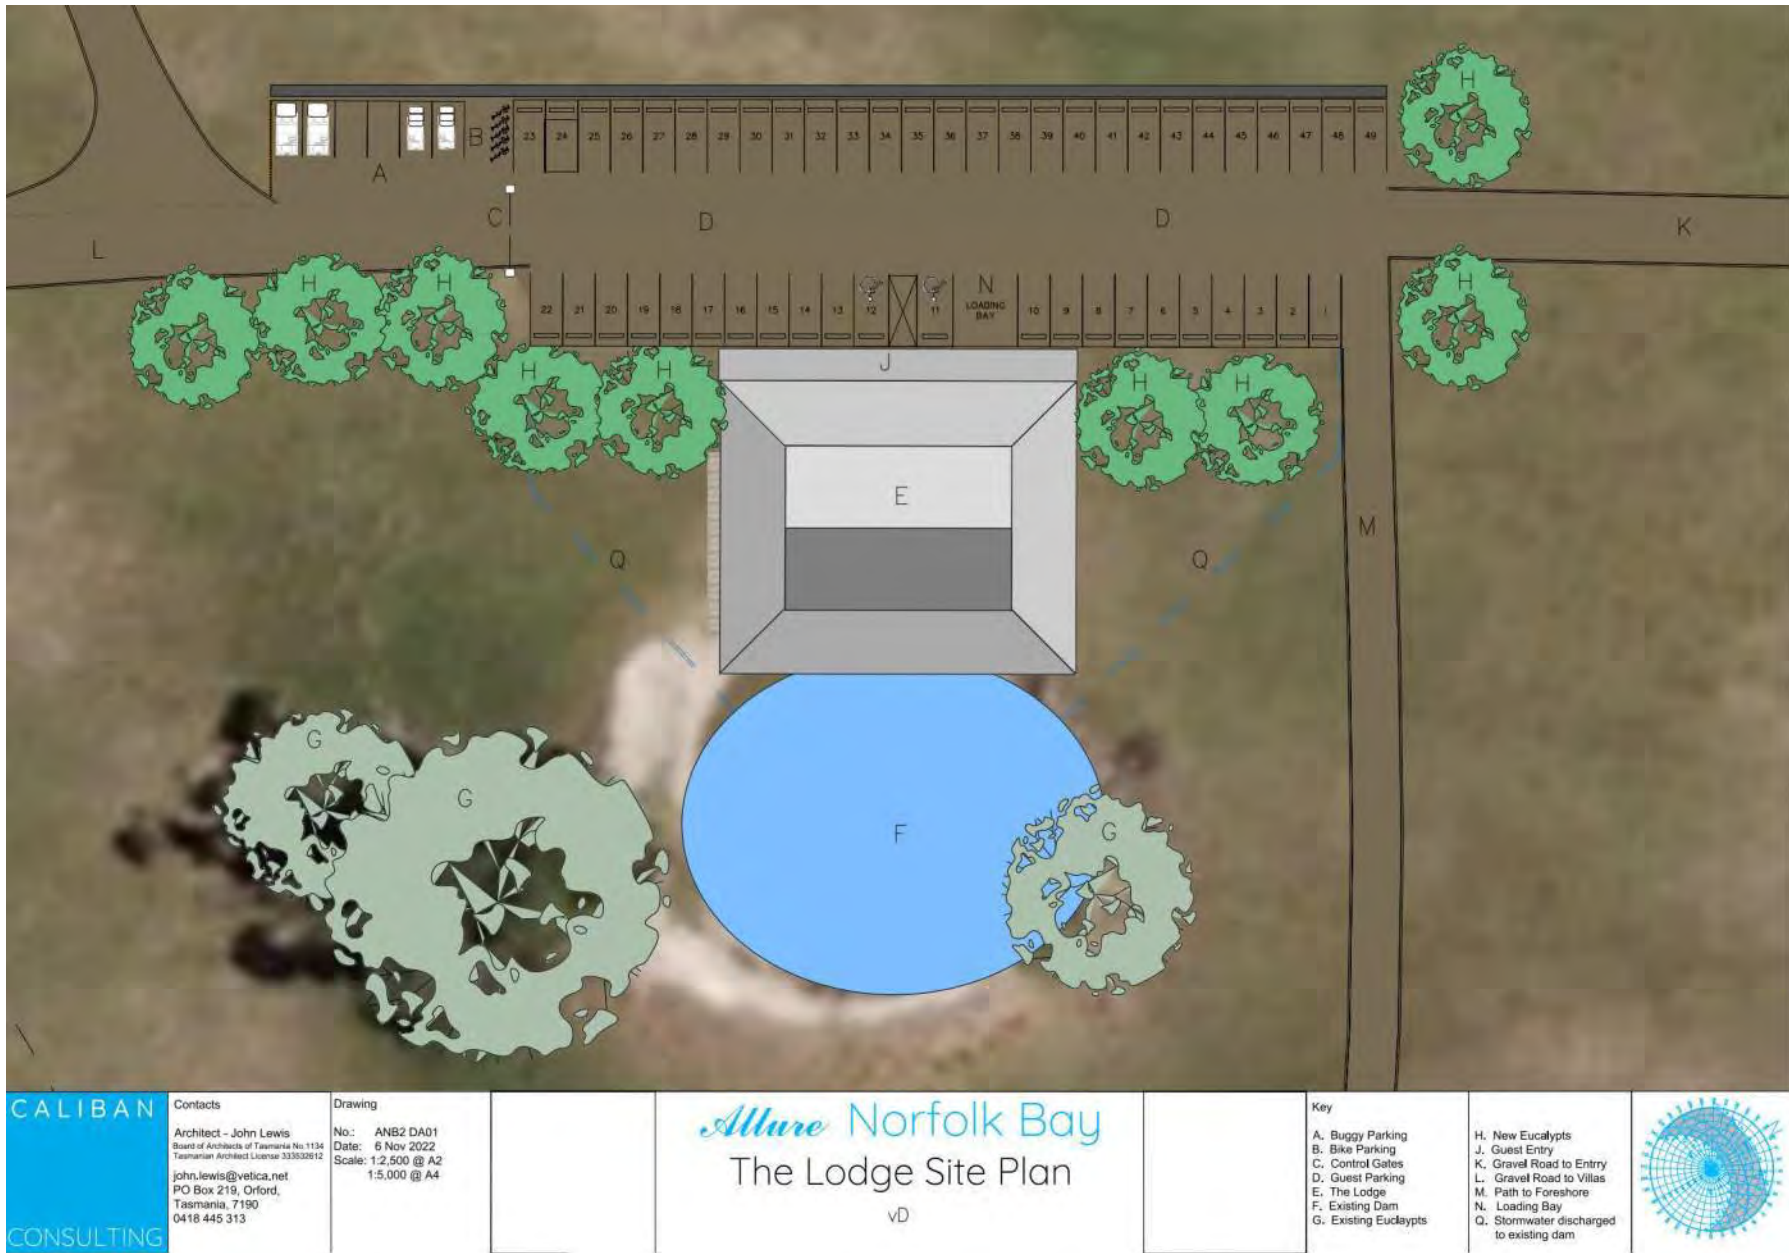
Image 2: Plan of Lodge building and carpark (Plan ANB2 DA01) with stormwater discharge channels and waterhole shown at items Q and F respectively

The proposed development is therefore consistent with the applicable Performance Criteria of the Stormwater Management Code (SIPS E7).

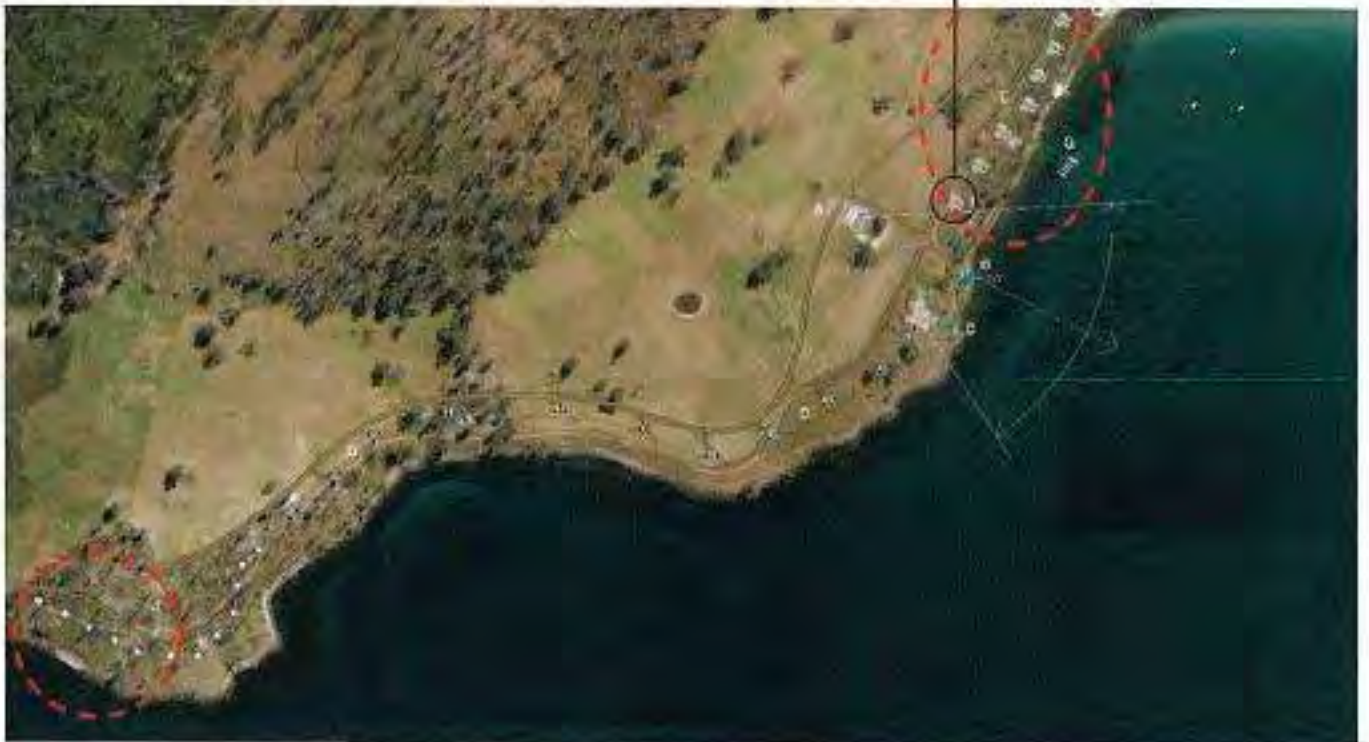
Cabin Type D - 1 and 2

The report investigates the suitability of trench for onsite effluent disposal for proposed buildings at Norfolk Bay, Primrose Sands.

The site has grass covering with trees in areas and has a medium slope of 9°. There was no water ponding observed on the site, and the site has an unlikely probability of saturation during heavier rain periods.

We recommend the use of a 1100mm x 7m trench

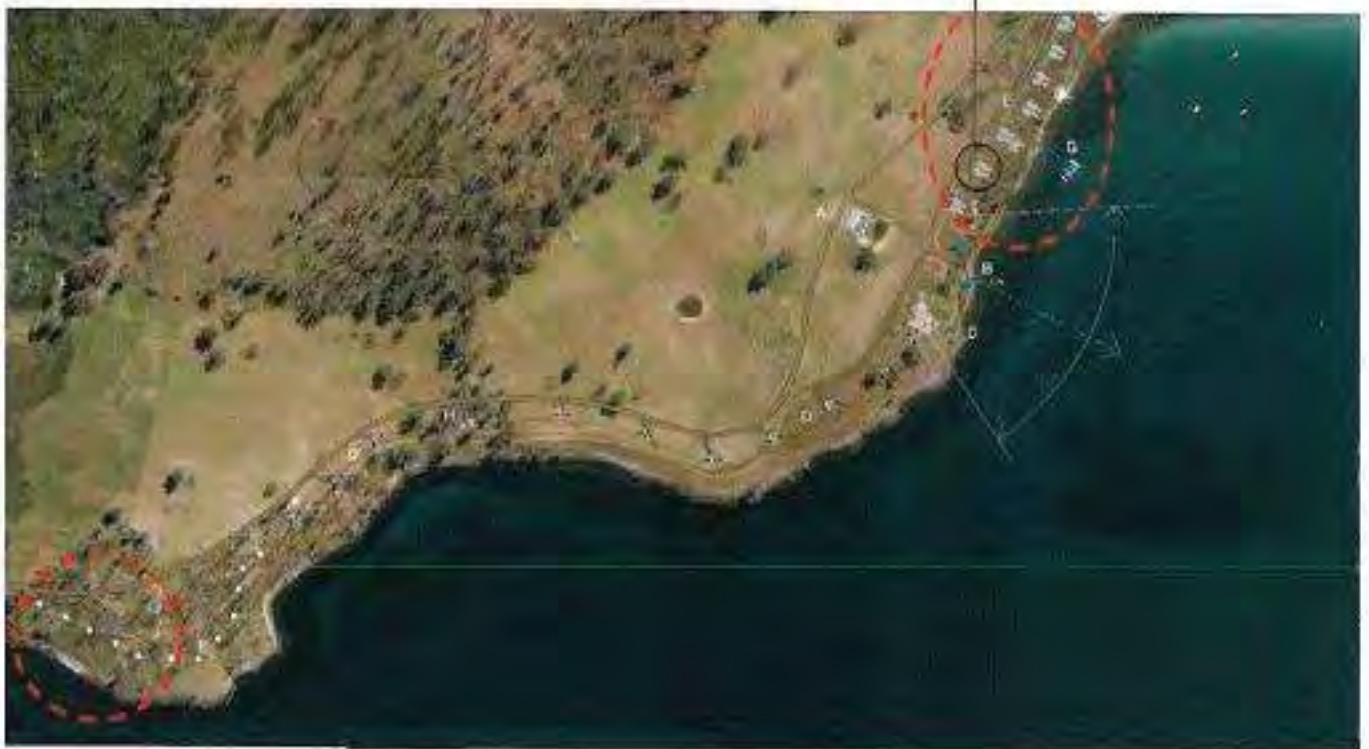
Cabin Type D - 3 and 4

The report investigates the suitability of trench for onsite effluent disposal for proposed buildings at Norfolk Bay, Primrose Sands.

The site has grass covering with trees in areas and has a medium slope of 9°. There was no water ponding observed on the site, and the site has an unlikely probability of saturation during heavier rain periods.

We recommend the use of a Wisconsin mound of size 11x7m

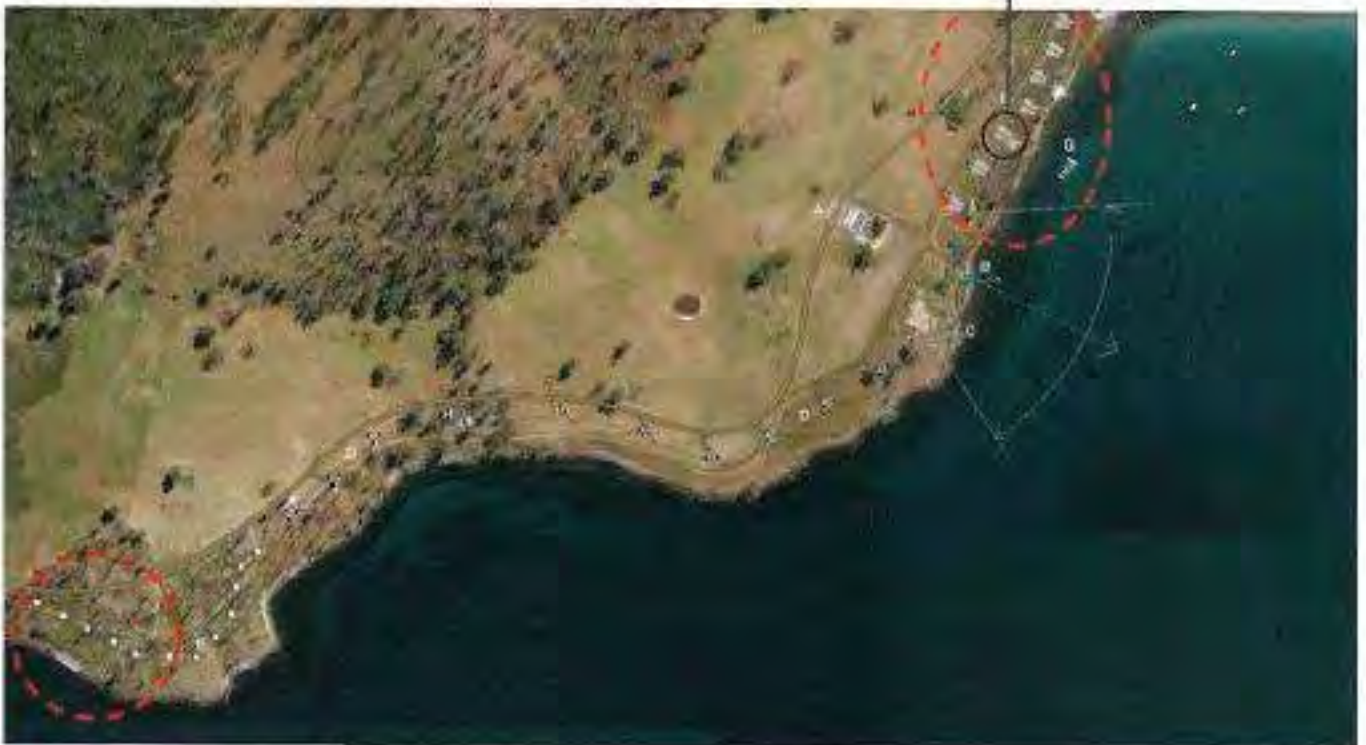
Cabin Type D - Sand 6

The report investigates the suitability of trench for onsite effluent disposal for proposed buildings at Norfolk Bay, Primrose Sands,.

The site has grass covering with trees in areas and has a medium slope of 9°. There was no water ponding observed on the site, and the site has an unlikely probability of saturation during heavier rain periods.

We recommend the use of a 1.5m x 1.5m trench of area 11.25m<sup>2</sup>

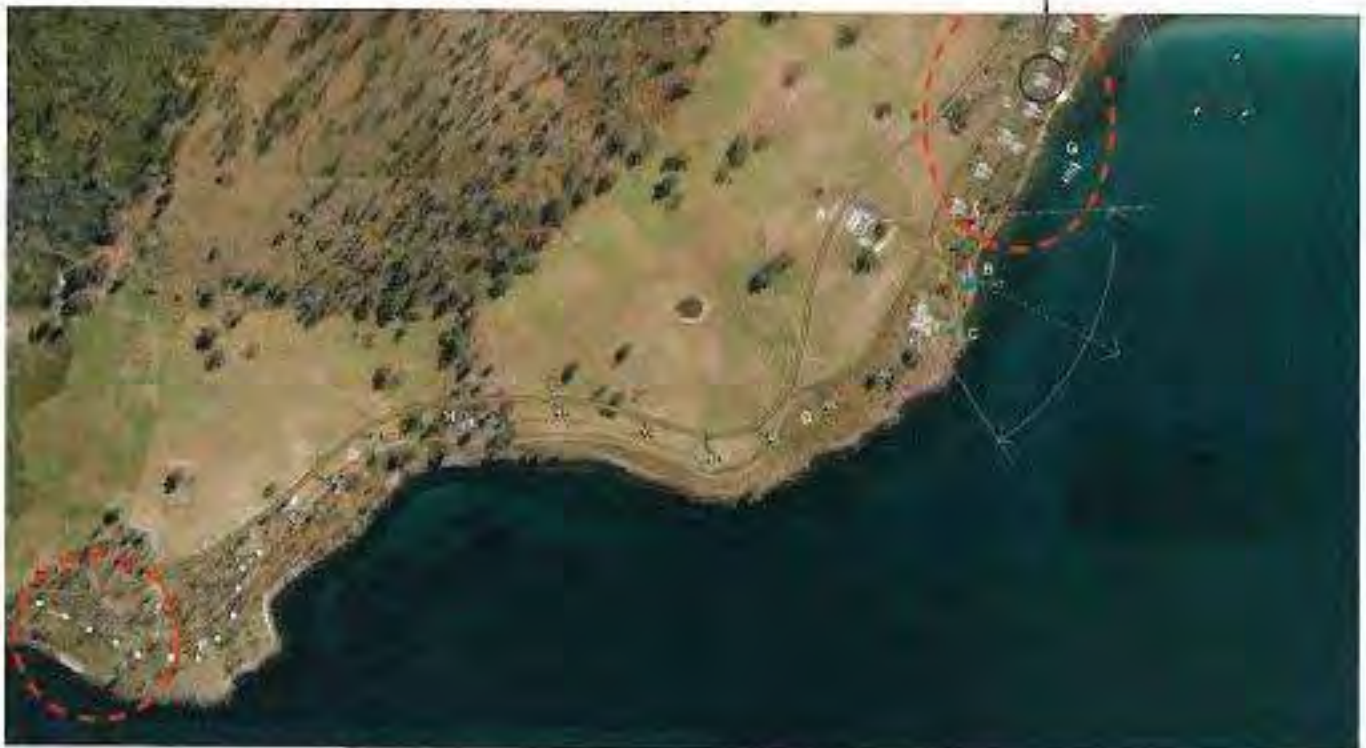
*Cabin Type D - 9 and 10*

The report investigates the suitability of trench for onsite effluent disposal for proposed buildings at Norfolk Bay, Primrose Sands.

We recommend the use of a Wisconsin manual 0.7m basal area

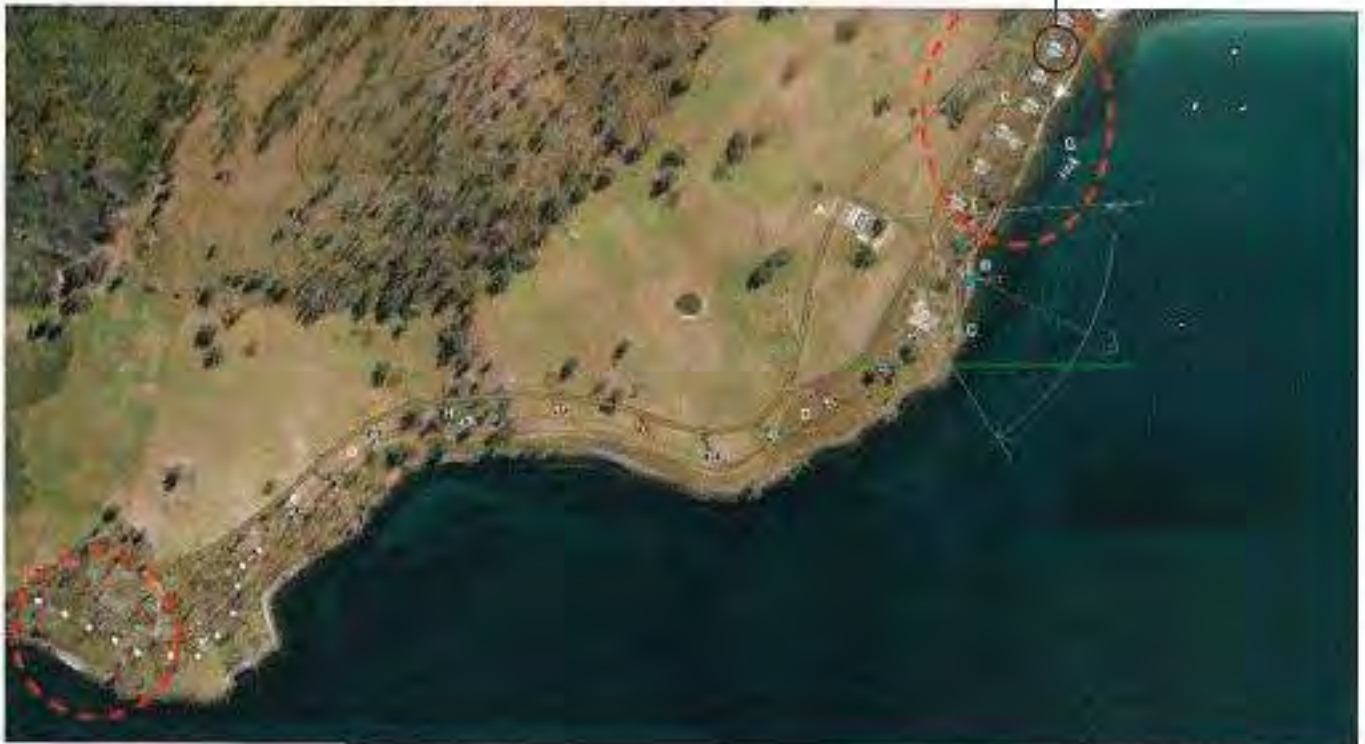
*Cabin Type D - 11 and 12*

The report investigates the suitability of trench for onsite effluent disposal for proposed buildings at Norfolk Bay, Primrose Sands.

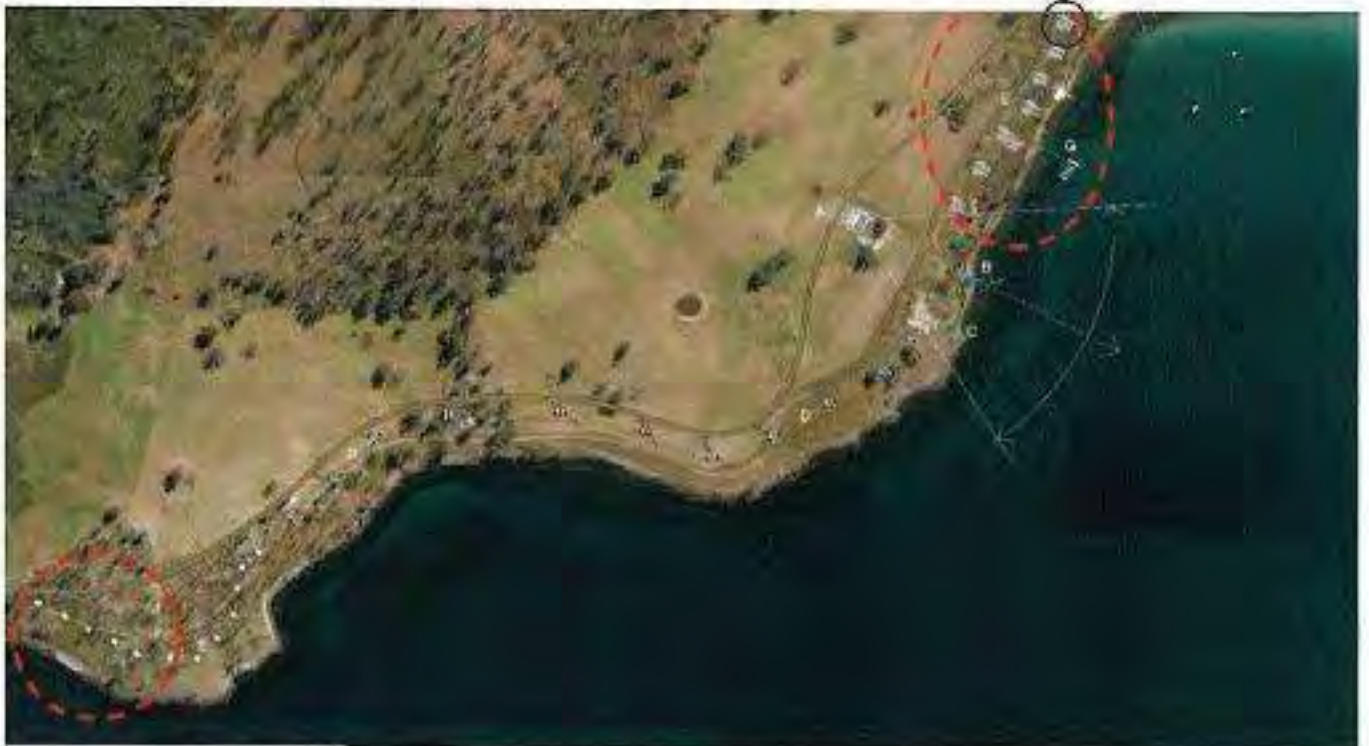
*Cabin Type D - 13 and 14*

The report investigates the suitability of trench for onsite effluent disposal for proposed buildings at Norfolk Bay, Primrose Sands.,
