## **GEOTECHNICAL INVESTIGATION**

Stroud Dairies

Proposed Dairy Shed and Dairy Effluent  
Storage Facility

GL24627Ab  
10 February 2025

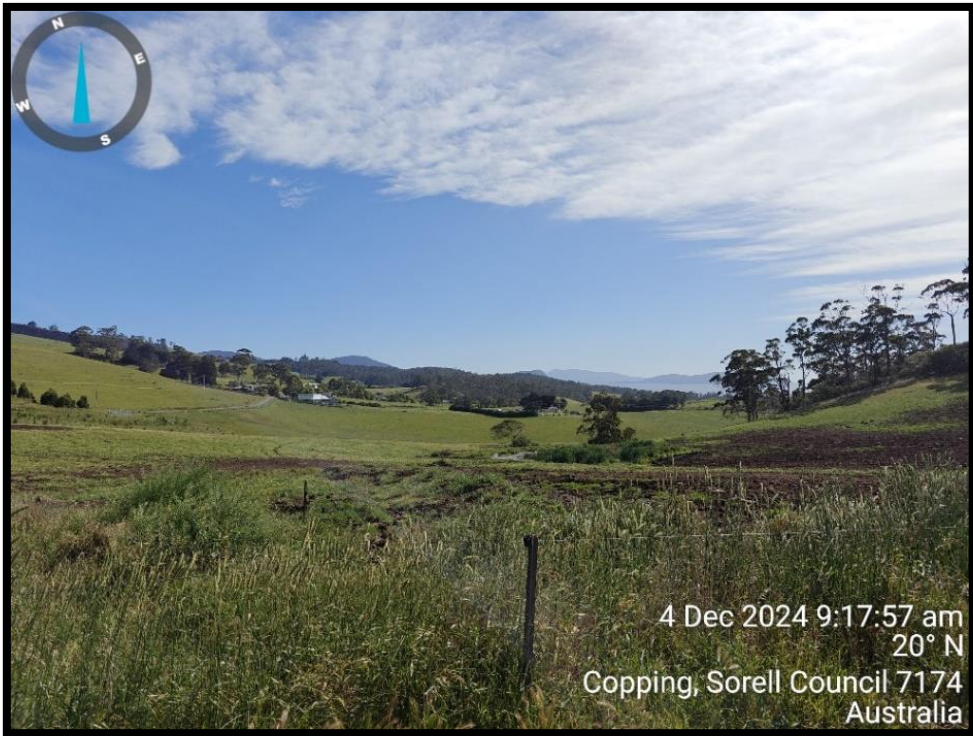
Plate 1: View of the proposed new effluent pond site looking to the north.

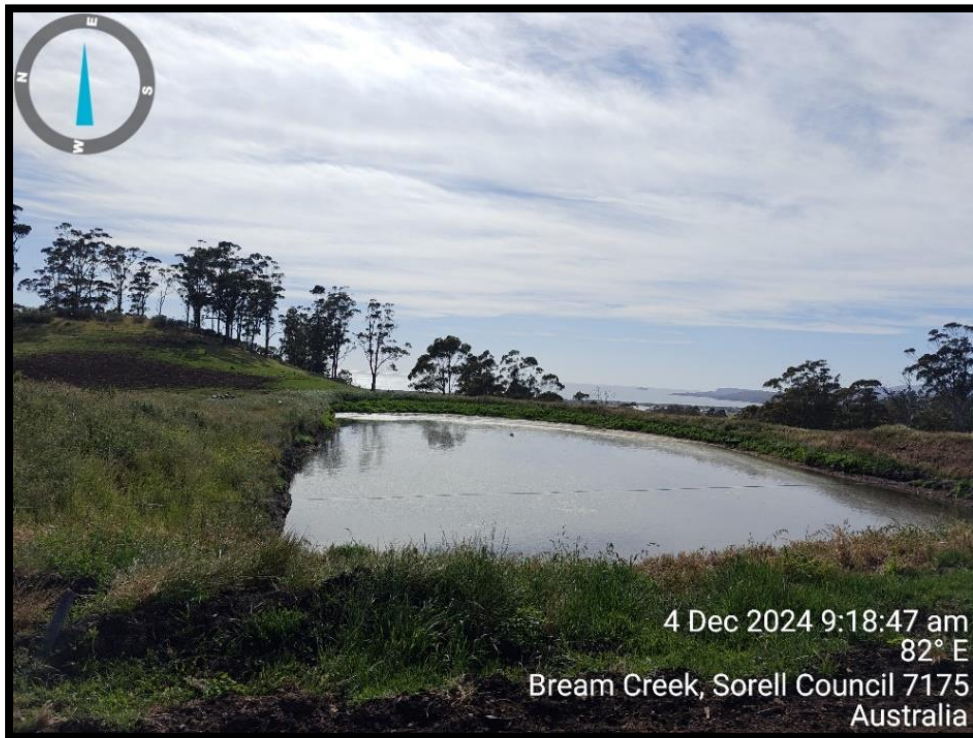
The existing effluent pond was full at the time of the field investigation and was observed to be generally in a good condition, with no evidence of dispersive soils.

Plate 2: View of the existing effluent pond looking to the east.

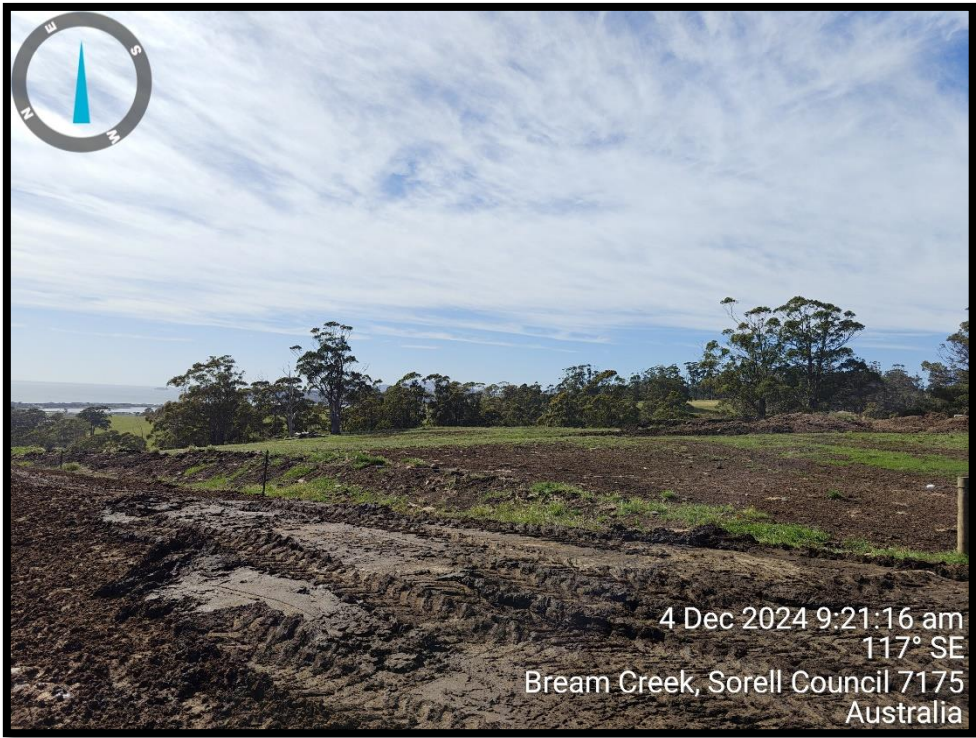
No springs or seeps were observed within the area of the existing effluent pond or proposed solids trench.

Plate 3: View of the proposed solids trench site looking to the southeast.

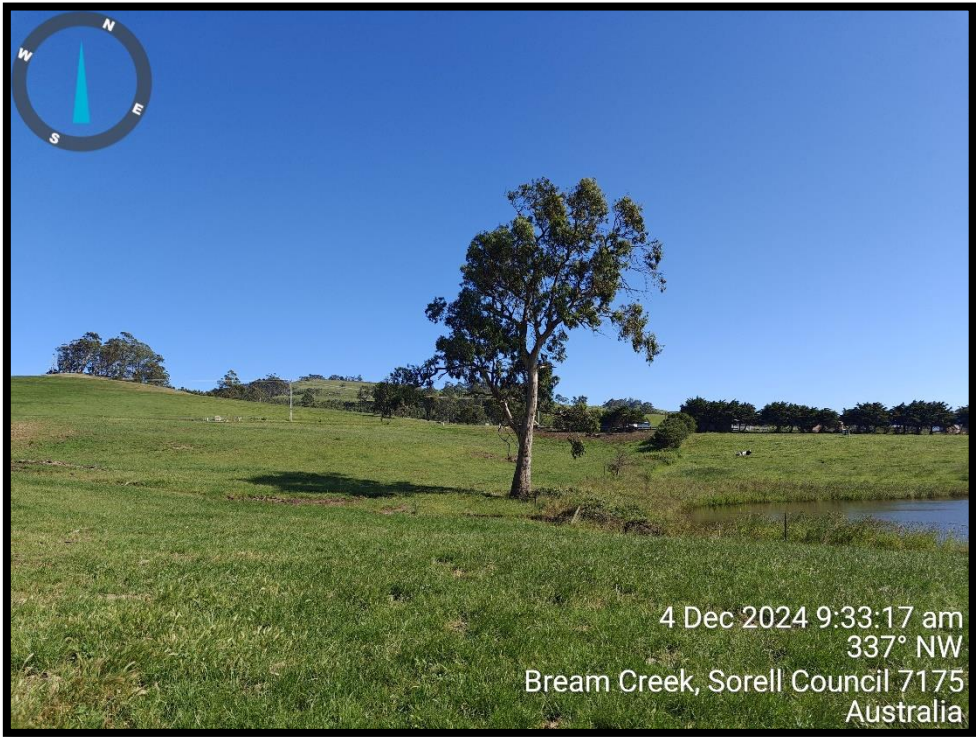
The dairy shed is to be located within an existing grazing paddock approximately 110m to the southwest of the existing dairy. The ground surface across the shed site is undulating, and generally has an easterly fall of approximately 6° to 10° and a cover of low grass. A pond, previously filled in and having soft saturated fill material, is located centrally within the shed site. A small dam is located immediately downslope of the proposed shed (Plates 4 and 5). Photographs of the site are provided as Plates 1 to 5.

Plate 4: View of the northern portion of the shed site looking to the northwest.

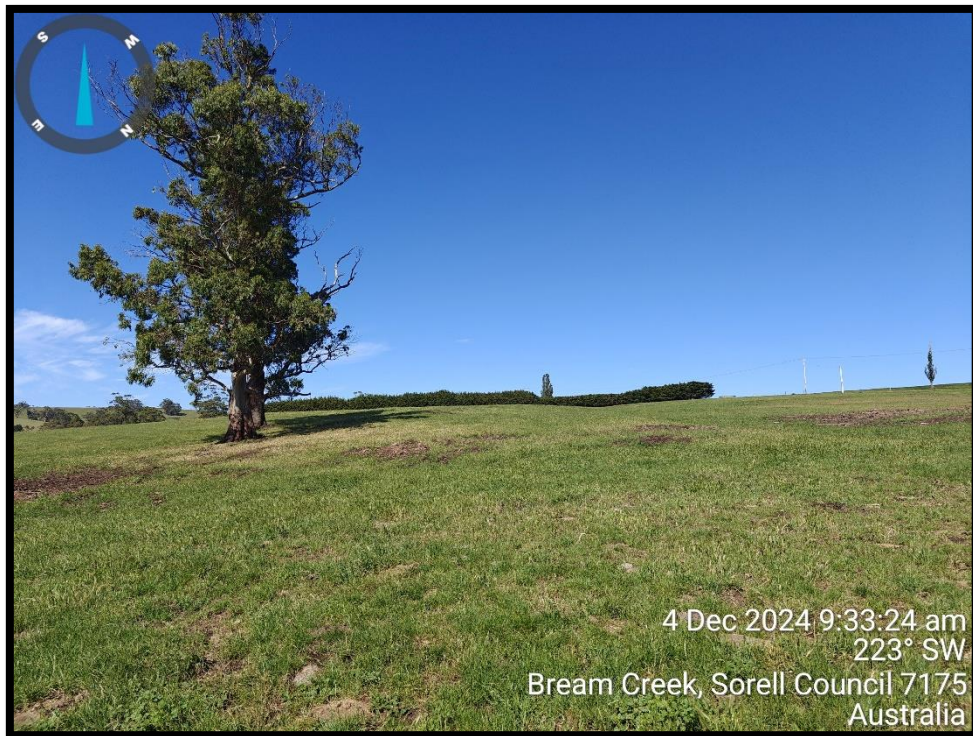
**Plate 5: View of the southern portion of the shed site looking to the southwest.**
