NOTICE OF PROPOSED DEVELOPMENT

6 LATEENA STREET, DODGES FERRY

**DEMOLITION OF EXISTING DWELLING, NEW DWELLING &
VISITOR ACCOMMODATION**

Proposed on-site wastewater management system at 6 Lateena Street, Dodges Ferry TAS 7173

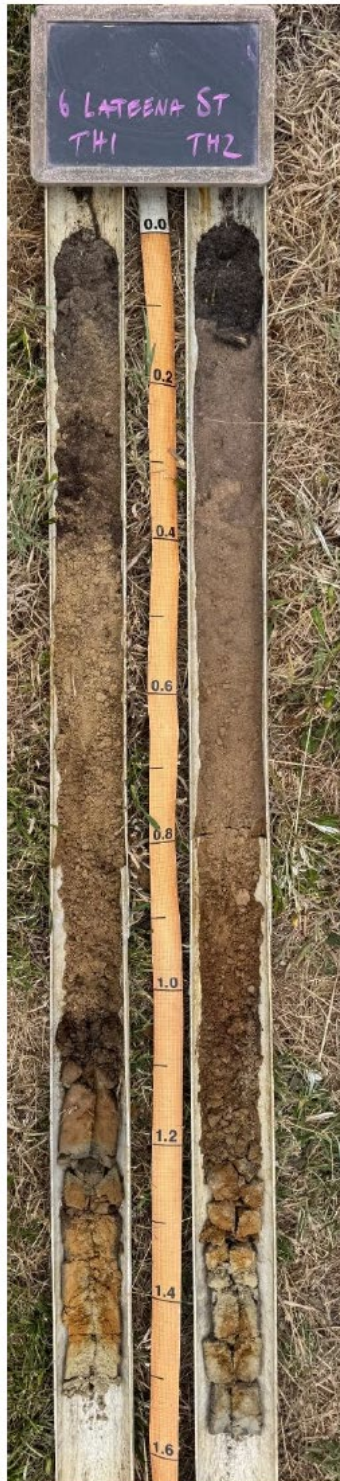
(above) – test cores from proposed land application area by Doyle Soil.

Soil profiles observed mirrored those described by Doyle Soil following a visit in January 2026. Soil profile descriptions by Doyle Soil in their Test Hole 2 are reproduced below; this test hole is considered to be representative of the area between the western side of the proposed house and the boundary with 4 Lateena Street, where the main (150m²) irrigation area will be located.

1. A1/A2 Horizon: 0 - 800mm: Very dark grey (10YR 3/1) grading to pale grey (10yr 6/3) Sand, poorly graded, dry loose. Category 1
2. A3 Horizon: 800-1200mm: Dark yellowish brown (10YR 4/6), Sand, poorly graded, slightly moist, medium dense. Category 1
3. B/C Horizon: Pale Olive (5YR 6/4) with common coarse yellowish-brown mottles, Loamy Sand, moderate coarse blocky, slightly moist soft friable, (Dense in situ). Category 2
4. CR Refusal on sandstone bedrock

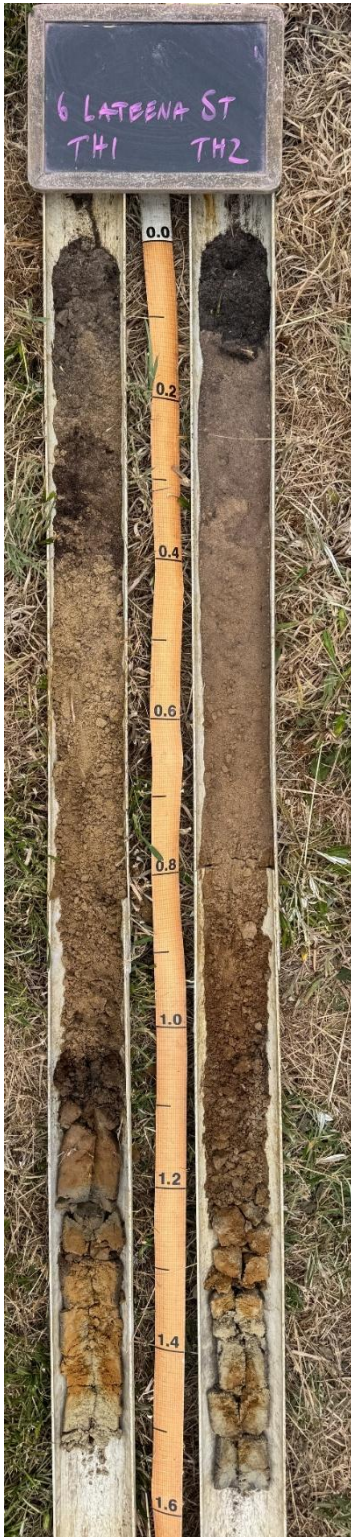
SOIL PROFILES – Test Hole 1

Depth (m)	Horizon	Description and field texture grade	USCS Class
0 – 0.6	A1/A2	Very dark grey (10YR 3/1) grading to to pale grey (10yr 6/3) Sand , poorly graded, dry loose	SP
0.6 – 1.1	A3	Dark yellowish brown (10YR 4/6), Sand , poorly graded, slightly moist, medium dense	SP
1.1 – 1.2	B2	Brown (10YR 5/3) with common coarse yellowish brown mottles, Sandy Light Clay , massive, moist firm consistency	CL
1.2 – 1.6	BC	Pale Olive (5YR 6/4) with common course yellowish brown mottles, Loamy Sand , moderate coarse blocky, slightly moist soft friable, (Dense <i>in situ</i>) REFUSAL on sandstone bedrock	SC

- Three test hole (TH) cores:
 - TH1 with refusal at 1.6 m
 - TH2 with refusal at 1.6 m
 - TH3 with refusal at 0.85 m
- two Dynamic Cone Penetrometer (DCP) tests:
 - DCP1 with refusal at 1.2 m
 - DCP2 with refusal at 1.2 m
- Emerson Dispersion test on subsoils and linear shrinkage tests on all likely founding layers.

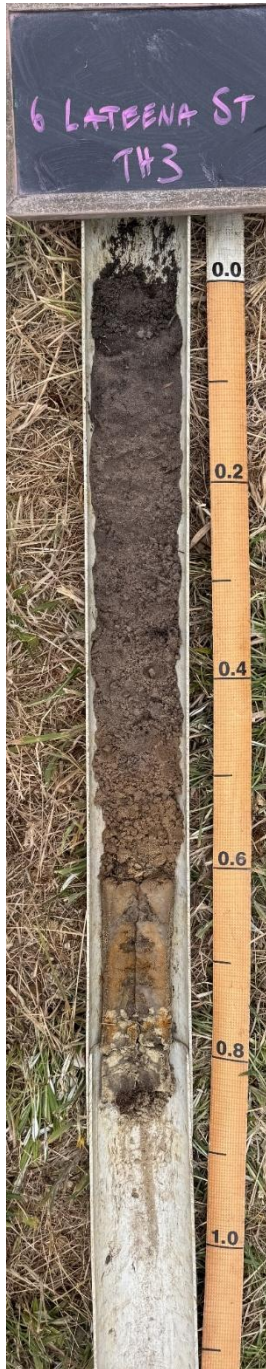
SOIL PROFILES – Test Hole 3

Depth (m)	Horizon	Description and field texture grade	USCS Class
0 – 0.5	A1/A2	Very dark grey (10YR 3/1) grading to pale grey (10yr 6/3) Sand , poorly graded, dry loose	SP
0.5 – 0.6	A3	DYB (10YR 4/6), Sand , poorly graded, slightly moist, medium dense	SP
0.6 – 0.75	B2	Brown (10YR 5/3) with common coarse YB mottles, Sandy Light Clay , massive, moist firm consistency	CL
0.75 – 0.85	BC	Pale Olive (5YR 6/4) with common coarse yellowish brown mottles, Loamy Sand , moderate coarse blocky, slightly moist soft friable, (Dense in situ) REFUSAL on sandstone bedrock	SC
