# NOTICE OF PROPOSED DEVELOPMENT

**SECONDARY RESIDENCE**

## **DISPERSION ASSESSMENT** **SOIL AND WATER MANAGEMENT PLAN**

## **SITE AND SOIL EVALUATION REPORT** **FOUNDATION AND WINDLOADING ASSESSMENT**

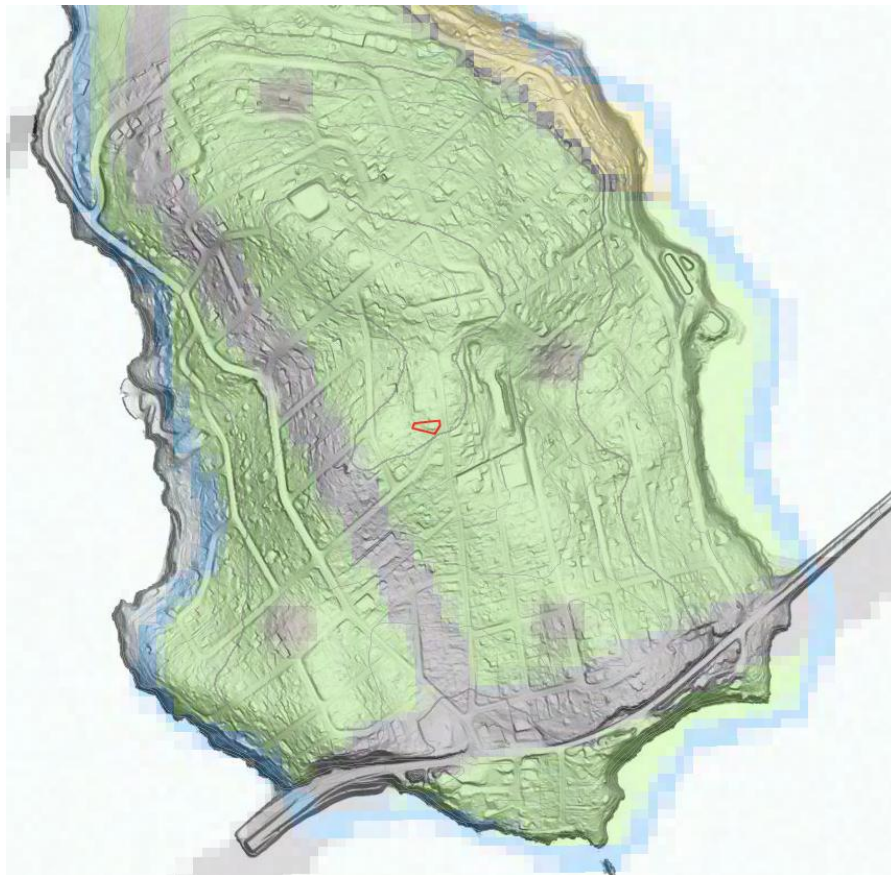
Figure 1: mapped lithologies in the environs around 22 Darwin, Midway Point (red polygon). Green areas = Triassic sandstone. 5 m contours.

The site is on Triassic quartz sandstone (Figure 1).

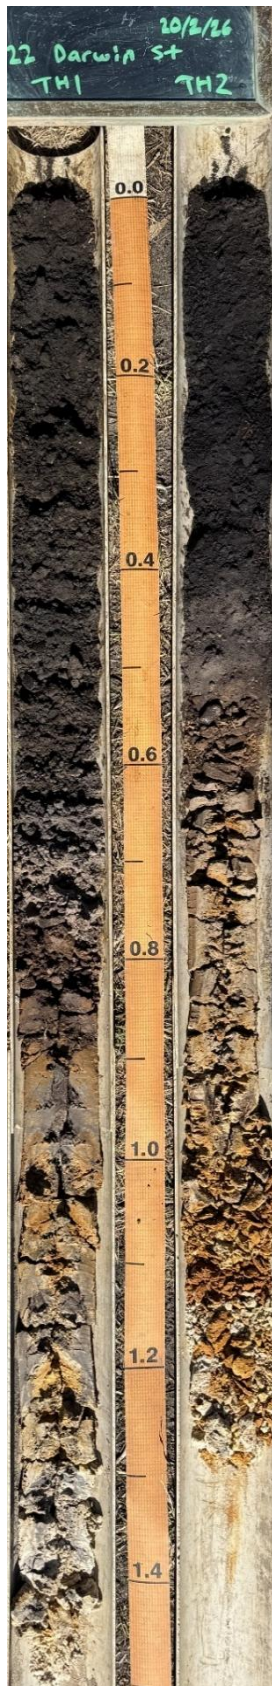
## SOIL PROFILES – Test Hole 1

| Depth (m) | Horizon | Description and field texture grade | USCS Class |
|---|---|---|---|
| 0 – 0.6 | A1 | Very dark greyish brown (10YR 3/2), <b>Sand</b> , poorly graded, dry loose consistency | <b>SP</b> |
| 0.6 – 0.8 | A2 | Gery (10YR 6/1), <b>Sand</b> , poorly graded, dry loose consistency | <b>SP</b> |
| 0.85 – 1.2 | B2 <sub>2</sub> | Dark grey (10YR 4/1) with common coarse brownish yellow mottles, <b>Sandy Silty Medium Clay</b> , weak coarse blocky structure, slightly moist stiff consistency | <b>CH</b> |
| 1.2 – 1.4 | BC | Mottled white (10YR 8/1), yellowish brown (10YR 5/8) and dark grey (10YR 4/1), <b>Silty Light Clay</b> , slightly moist firm consistency, weak coarse platy structure<br><br><b><u>REFUSAL ON SANDSTONE BEDROCK</u></b> | <b>CL</b> |

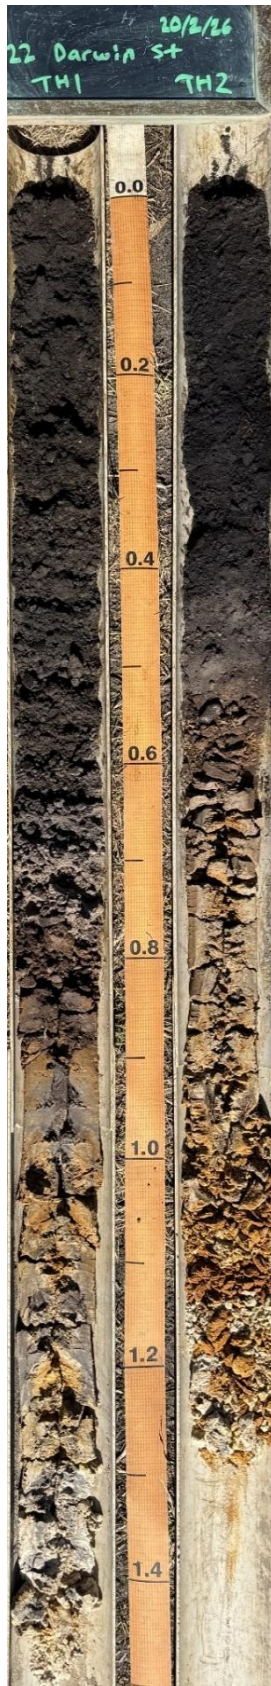
## SOIL PROFILES – Test Hole 2

| Depth (m) | Horizon | Description and field texture grade | USCS Class |
|---|---|---|---|
| 0 – 0.4 | A1 | Very dark greyish brown (10YR 3/2), <b>Sand</b> , poorly graded, dry loose consistency | <b>SP</b> |
| 0.4 – 0.5 | A2 | Grey (10YR 6/1), <b>Sand</b> , poorly graded, dry loose consistency | <b>SP</b> |
| 0.6 – 1.0 | B2 <sub>2</sub> | Dark grey (10YR 4/1) with common coarse brownish yellow mottles, <b>Sandy Silty Medium Clay</b> , weak coarse blocky structure, slightly moist stiff consistency | <b>CH</b> |

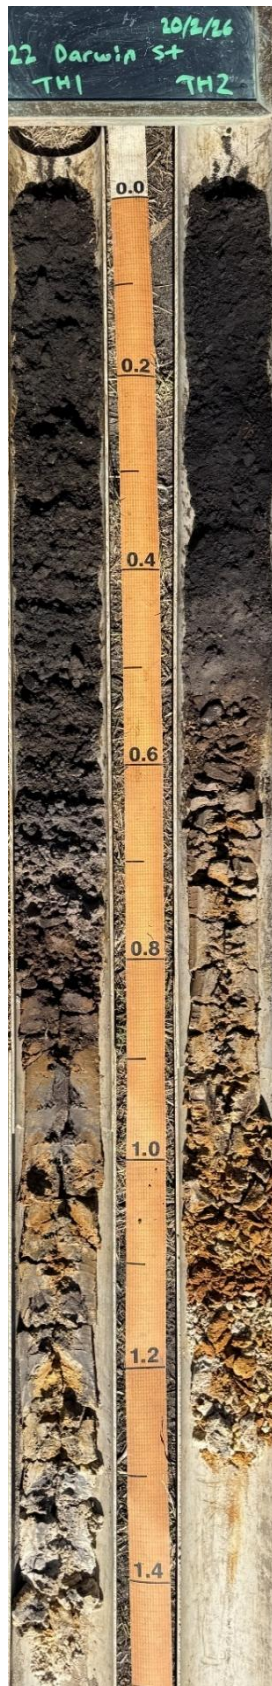
## SOIL PROFILES – Test Hole 1

| Depth (m) | Horizon | Description and field texture grade | USCS Class |
|---|---|---|---|
| 0 – 0.6 | A1 | Very dark greyish brown (10YR 3/2), <b>Sand</b> , poorly graded, dry loose consistency | <b>SP</b> |
| 0.6 – 0.8 | A2 | Gery (10YR 6/1), <b>Sand</b> , poorly graded, dry loose consistency | <b>SP</b> |
| 0.85 – 1.2 | B2 <sub>2</sub> | Dark grey (10YR 4/1) with common coarse brownish yellow mottles, <b>Sandy Silty Medium Clay</b> , weak coarse blocky structure, slightly moist stiff consistency | <b>CH</b> |
| 1.2 – 1.4 | BC | Mottled white (10YR 8/1), yellowish brown (10YR 5/8) and dark grey (10YR 4/1), <b>Silty Light Clay</b> , slightly moist firm consistency, weak coarse platy structure<br><br><b><u>REFUSAL ON SANDSTONE BEDROCK</u></b> | |

The soil profiles are formed from windblown sands over clayey residual soil derived from the underlying Triassic sandstone bedrock. The profiles are moderately deep, with effective refusal occurring at approximately 1.0 to 1.7 m. The field textures of the soil profile are dominated by clay, which is moderately reactive, weakly / moderately structured and mildly dispersive. DCP1 indicates a low bearing capacity to at least 1.1 m. Founding on the underlying, highly competent, sandstone bedrock, at approximately 1.0 – 1.7 m depth, is recommended.
